REPARATURNO NAVARIVANJE KOROZIONIH OŠTEĆENJA NA POSUDAMA POD PRITISKOM U HIDROELEKTRANI „ĐERDAP 1“

Repair welding of corrosion damaged pressure vessels in the “Đerdap 1” Hydro-electric power plant

The procedure used for repairing of two pressure vessels located at the “Đerdap 1” hydro-powerplant in Kladovo is shown in this paper. Pressure vessels are a part of the turbine generator fire protection system. Damages on the vessel interior were detected by the technical staff of “Đerdap 1” hydro-powerplant, during the preparations for regular internal examination. Damages that have occurred in these vessels are the consequence of inadequate anti-corrosion protection of internal vessel surfaces on the manufacturer’s end. Vessels were connected by a system of connectors, and one of them contains the water-air work fluid, whereas as the other only contains air. The manual arc welding procedure (or MAW) is used for repairing of damages and removing of defects on vessels. Requirements that must be fulfilled in order for a repair welding technology to be performed successfully, which would ensure that the vessels can be put back into exploitation, as well as advice for preventing further d

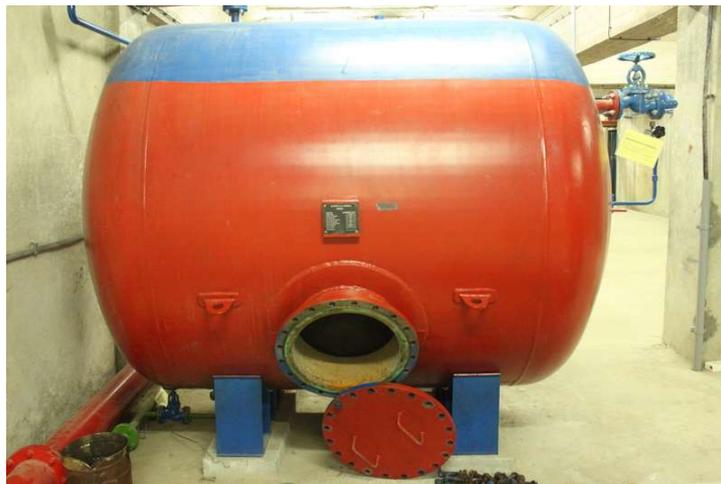
Figure 1 Water vessel in the fire protection system.

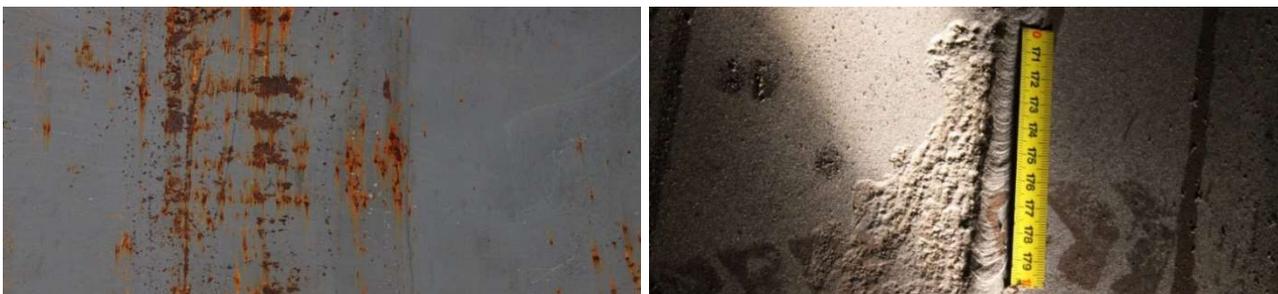
During the preparation for a regular internal inspection of pressure vessels by the appointed body, the technical staff of HPP "Đerdap 1" have discovered corrosion damages on the surfaces on the inner side of the vessels at the mantles and lids of both vessels (Figure 2 on the left). In addition, the inspection revealed more unacceptable errors, such as the incomplete penetration at the root, incisions, lack of penetration (Figure 2 right) etc. Inadequate anti-corrosion protection of the inner surface of the vessels cause the "good" conditions for the corrosion development. Besides that, environment itself and operating fluids in the vessels (water and water-air) are suitable for the corrosion creation and development.

Figure 2 Left) Corrosion damages on the vessel mantle, right) incomplete penetration at the root of the groove.

After measuring was performed, the thicknesses of pipes on the lids were obtained in the range of 9.6 - 9.8 mm, and on the mantle in the range of 6.8 - 9.3 mm. Nominal thickness of the mantles and the lids of both vessels was 10 mm, and it was found that the thickness of the thinning was 3.2 mm. The projected additive for corrosion and wear is 1 mm, so 3.2 mm thinning is unacceptable.

Inspection of welded joints was also performed, along with the ultrasonic thickness measurement. It has been determined that errors in welded joints are present and were created during the production of the vessel. Errors that were discovered included linear porosity, clusters, edge incisions, inclusions, incomplete penetration at the root, etc.

After inspection and obtaining of results, it was decided to apply the repairing method of both vessels using the selected welding procedure. Repair welding procedure is also used to correct all errors detected during the inspection. Prior to the beginning of repair welding, the adequate technology should be developed by the IMS Institute and, after being approved by the Appointed Body, it can be used to repair the damaged surfaces and welded joints of both vessels.

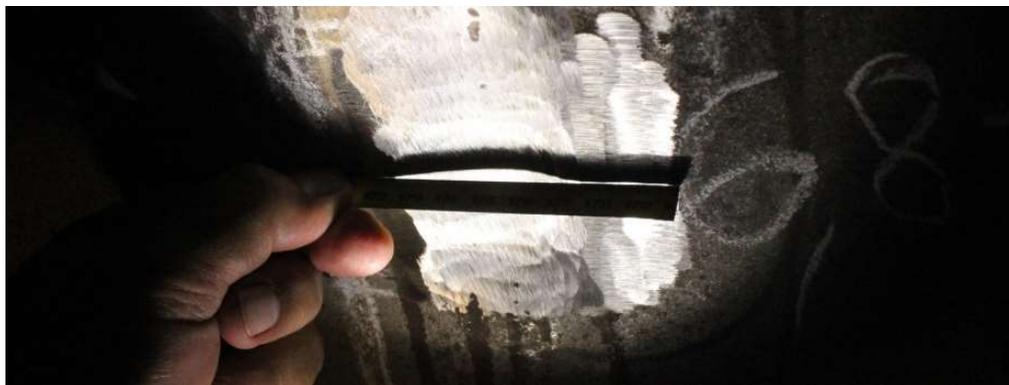
thickness was performed on the mantles and the lids on both vessels, at the damaged locations. Before measuring, damaged surfaces were machined. Corrosion damages were also removed in order to obtain valid measurement results (Fig. 3).

Figure 3 Removing of corrosion damage and preparation for ultrasound measurement of thickness.

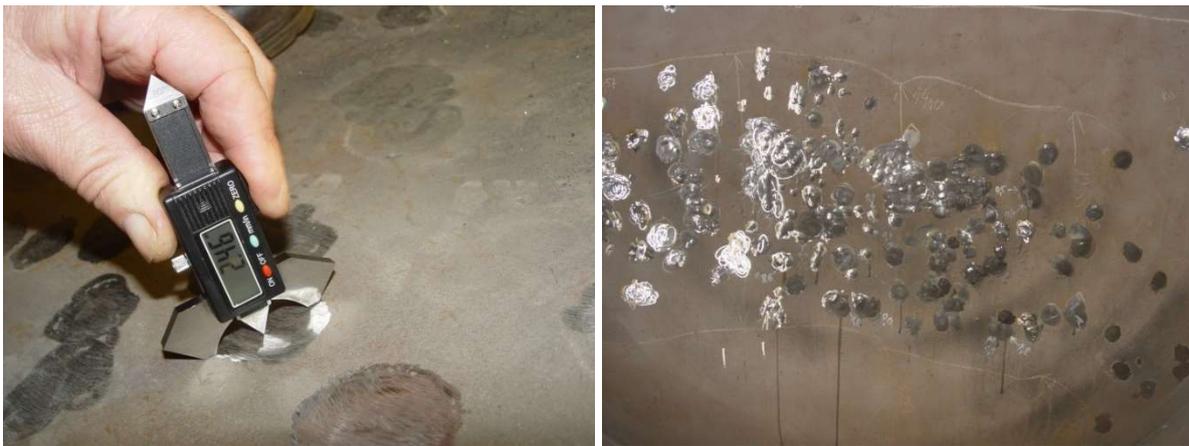
Figure 4 left) Machined zone, right) Appearance of prepared surface for welding.

Corrosion affected areas in the damaged zones are at least 20 mm wide, and they are machined up to the metal shine in order to eliminate defects, corrosion traces and sharp edges. Defect removal was carried out under constant magnetoflux or penetrants control depending on the size of the zone. The appearance of the machined zone can be seen in Figure 4 on the left side.

Defects in welded joints that have occurred during exploitation are also removed using machining under, constant control of liquid penetrants. The appearance of the prepared surfaces after the control can be seen in Figure 4 on the right side. After removing the defects, the processing of the machined zones was performed in order to remove all sharp edges and to prepare surfaces for applying the welds. Appearance of one of the zones after additional processing and control is shown in Figure 5.

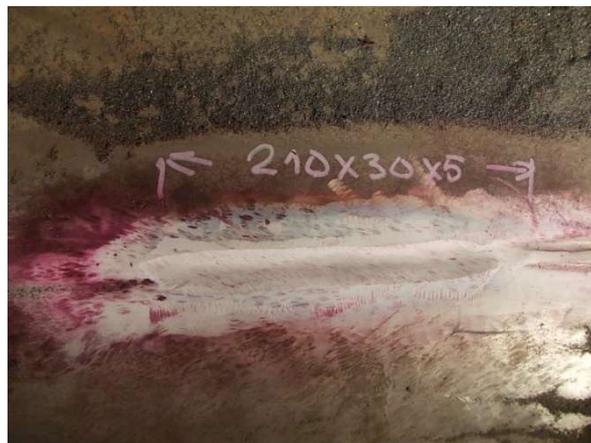
Figure 5 Prepared surfaces for welding after additional processing and liquid penetrant control.

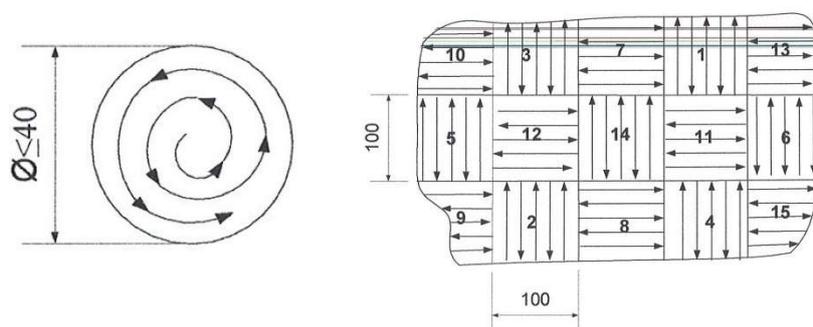
Figure 6 left) Welding procedure with spiral grinded surfaces $\varnothing < 40$ mm; right) welding procedure for grinded surfaces greater than 200 cm² (second layer)

Welding is performed with a short arc with permanent removal of slag. Special attention is paid to filling the craters caused by breaking of the electric arches. Each subsequent weld is overlapped with previous one to 1/3 of the width. In order to reduce the residual stresses due to heat input, in the case of surfaces where grinding was performed in a spiral way with diameter less than 40 mm, welding was also performed in a spiral way, as can be seen in Figure 6 (left). For grinded surfaces with an area up to 200 cm², welding of the bottom and lateral sides were performed by rotating the direction of the welds by 90° for each layer, as well as rotating the direction of laying for each weld. In the case of grinding surfaces greater than 200 cm², the first layer is welded in the direction of the reservoir axis, but the next layer was applied as divided squares with sides of 100 mm (Figure 6 right). Each subsequent layer is welded perpendicular to the previous one.

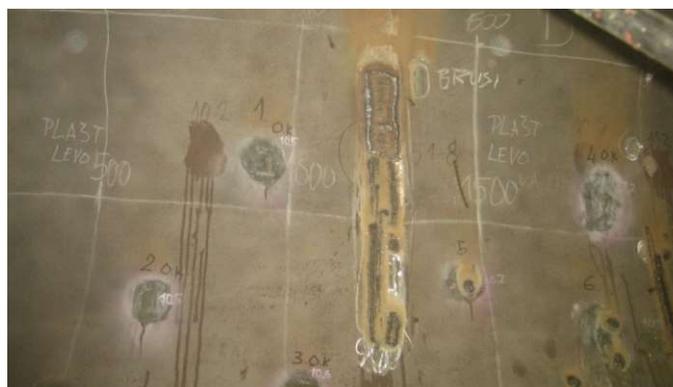
Figure 7 Appearance of welded zones.

For narrow and long grind surfaces, welding with "backstop" was applied. The appearance of welded zones can be seen in Figure 7.

Welding of both vessels was carried out at an ambient temperature greater than 5 °C. After welding was performed, excessive overhangs were removed and the welds were reduced to the level of the parent material. The welding parameters are shown in Table 7.

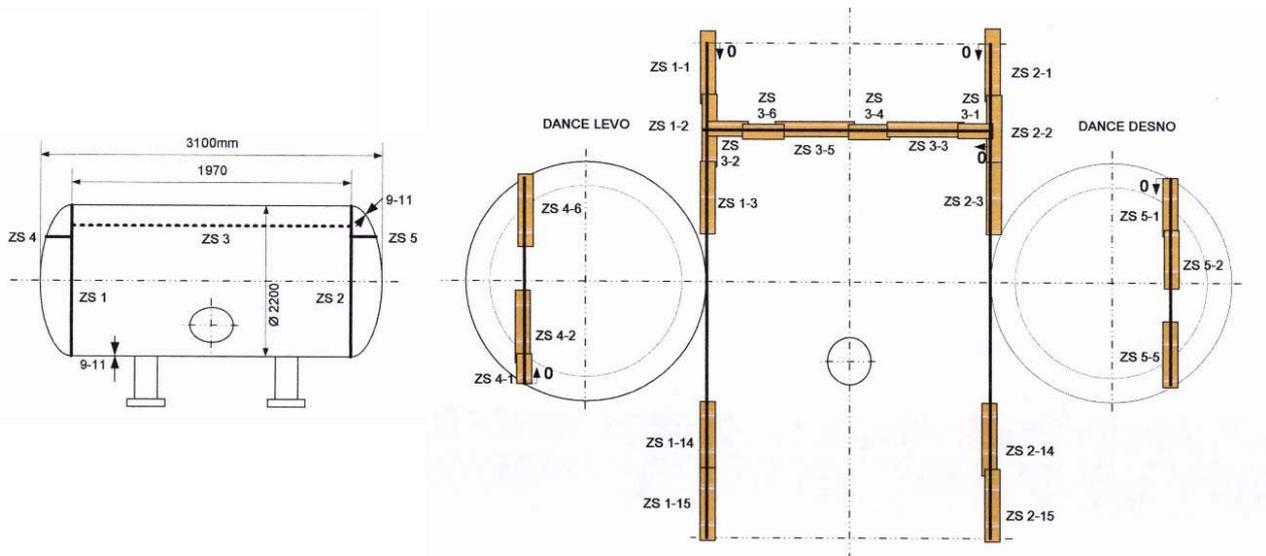
Figure 8 Radiograms distribution during radiographic control of welded joints.

The repair of the damaged surfaces of both vessels was performed successfully, in accordance with the selected technology. NDT control revealed that there are no defects in welds and welded joints on both vessels. After all of the welding processes were completed and NDT tests were carried out, strength pressure testing was performed on both vessels with cold water in the presence of the appointed body. Pressure of 10.4 bar was determined, based on the technical documentation of the vessels. The control manometer with a measuring range of 0 - 16 bars, with an accuracy of 0.6 was used. During and after the examination, there were no signs of moistening, dehumidification and leakage on the parent material and welded joints of the vessels. Signs of deformation of the equipment were not observed. Water pressure testing was performed successfully and it was concluded that the vessels can be returned in exploitation after the AKZ regeneration.

Liquid penetrant controls have been performed on welds in order to detect possible defects, and were carried out within the scope of 100%. In addition to penetrant control, ultrasonic measurement of the thickness of repaired surfaces was performed as well as radiographic control of all welded joints and parent material in order to investigate the homogeneity of welded layers. Figure 8 shows the locations of radiograms during radiographic control.
