SANACIJA PODNOG EKRANA KOTLA TOPLANE U VALJEVU

Sanation of bottom panel of boiler in heating plant Valjevo

Nikola Milovanović¹, Branislav Đorđević¹, Simon Sedmak¹, Uroš Tatić¹, Emina Džindo¹

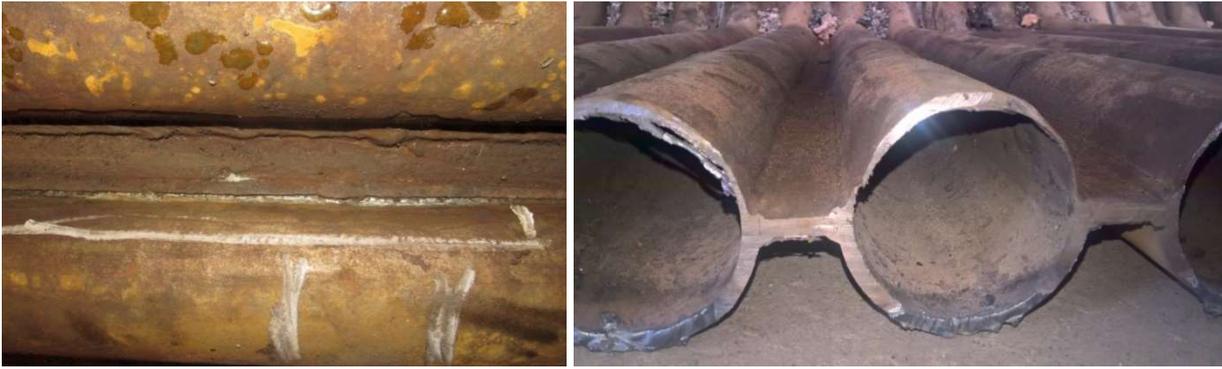
During the preparation for a new heating season and after visual inspection of the boiler, it was noticed that the pipes in the bottom panel were damaged, and that it should be further examined for the purpose of determining of the extent of damage (figure 2 left). Due to exploitation conditions, which included frequent starting and stopping of the analyzed boiler work (the boiler is not working during the night), material loss occurs in internal membrane wall surfaces. Due to moisture separation on membrane walls, water bonds with the residual sulfur-trioxide, which results in the forming of sulfuric acid – H₂SO₄, which causes low temperature corrosion. As the bottom panel is slightly sloped, sulfuric acid accumulated in it. It aggressively affects the metal, resulting in parent material damage.

Fig. 2 Left) Damage of bottom panel at the connection between the membrane and pipe; Right) pipe wall thinning

In order to make the proper decision about the need for repairing and the adequate technique for it, i.e. the need to replace the bottom panel, ultrasound measuring the pipe wall thickness was performed. Pipe wall thinning was confirmed by a report wherein it can be seen that the wall thickness was reduced by 30%. Measured thickness ranged from 3.0 to 4.4 mm, compared to the design thickness of 4.5 mm. After the results were obtained, it was decided to repair the part of the bottom panel, including pipes 6 to 29, when viewed from the left lateral side. The repairing involved the replacement of pipes in the bottom panel. During the repairing, non-destructive tests were carried out by the Welding Institute, whereas the complete repair process was monitored by the appointed body. After the first dismantling of the pipes it was observed that the biggest thinning and damage occurred in the zone around the connection between the pipe and the membrane (Figure 2 right).

After measuring, it was determined that the pipe wall thickness in the zone of the connection between the membrane sheets and pipes, ranged from 1.3 to 3.2 mm. It was decided to extend the repairs to all 35 pipes of the bottom panel along the length of 3500 mm from the boiler front wall.

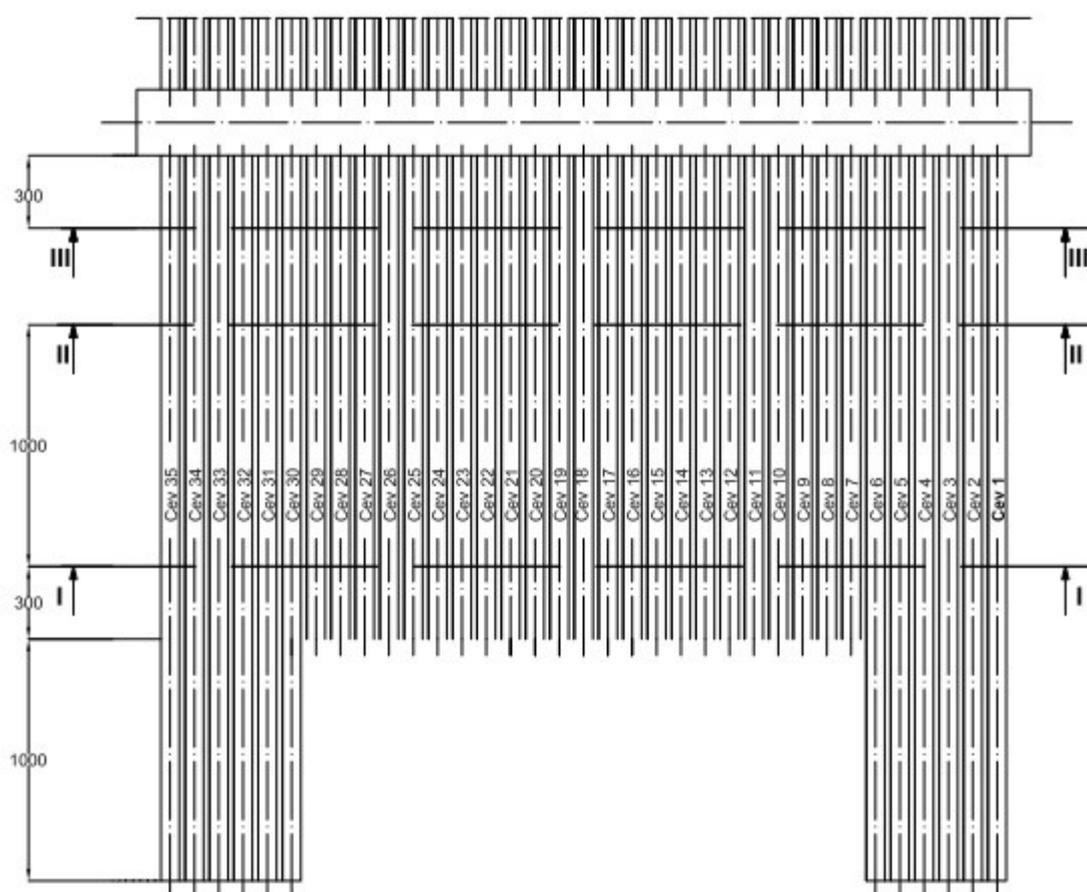
Repeated measuring of pipes tickness of boiler bottom panel was performed by the Welding Institute for three cross-sections [8]. Shown in figure 3 is the bottom panel of the boiler, including the cross-sections that were measured. The first cross-section is located at a distance of 300 mm from the original cutting line, the second one is located 1000 mm from the cross-section I-I and the third measured cross-section is located at a distance of 300 mm from the collector.

Fig. 3 Bottom panel test zones

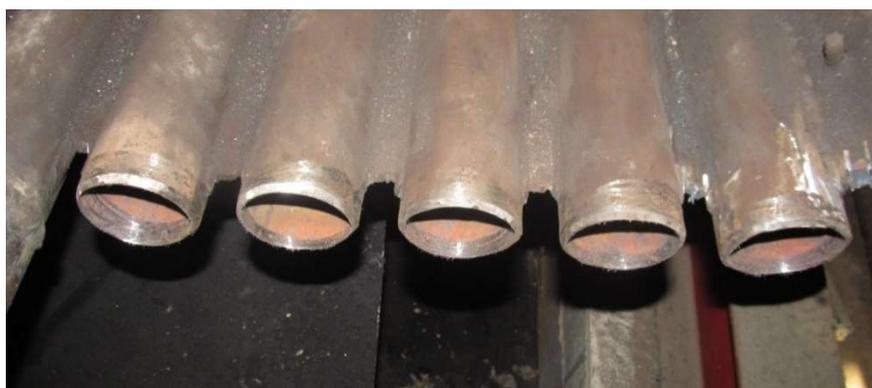
Fig. 4 Prepared bottom panel pipes – cleaned and degreased pipes

Appropriate WPS lists were created for the purpose of repairing of the bottom panel, including WPS lists for the connection between new and old pipes as well as between pipes and membrane strips. Cutting along the line of all damaged pipes of the bottom panel was performed (35 pipes with a length of 3500 mm). After the cutting, the ends of seamless pipes were prepared for welding according to the technology prescribed by the WPS lists. Edges of the pipes ends were filleted and these ends were cleaned and degreased as seen in Figure 4.

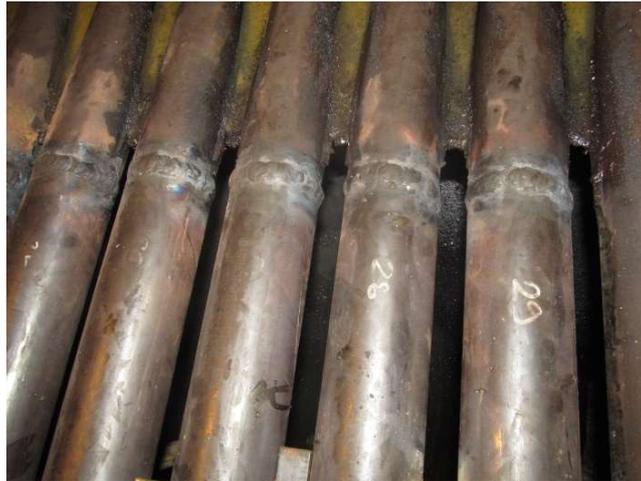
Fig. 5 Connecting of old and new pipes of the bottom panel

The ends of new seamless pipes, which are built into the boiler combustion chamber, were also prepared, in accordance with the technology specified by the contractor. Pipes were connected using the gas-flame welding procedure. Shown in Figure 5 is the appearance of the connected pipes.

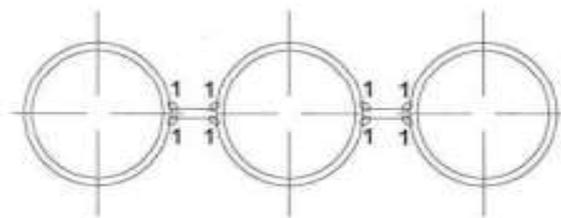
Fig. 6 Welding of membrane strips to the pipes

After the new and old pipes have been connected, welded joint inspection was performed via radiographic technique. It was performed by the Welding Institute. Since the welding was successful (there were no defects in the welded joints), welding of membrane strips and the pipes was performed next. It was performed according to the welding technology prescribed by the contractor “Topling-grejanje” [12]. Membrane strips were connected to the pipes using a MAG procedure. The welded joint can be seen in Figure 6.
