**METODOLOGIJA REPARATURNOG ZAVARIVANJA PRSLINA
NA LIVENOM DELU GLAVČINE ROTORA GENERATORA
AGREGATA A4 NA HIDROELEKTRANI ĐERDAP 1**

**METHODOLOGY OF REPAIR WELDING IN ZONES WHERE CRACKS
WERE DETECTED ON THE CASTED PART OF THE GENERATOR
ROTOR HUB OF THE HYDROELECTRIC GENERATING
SET A4 AT HYDRO POWER PLANT DJERDAP 1**

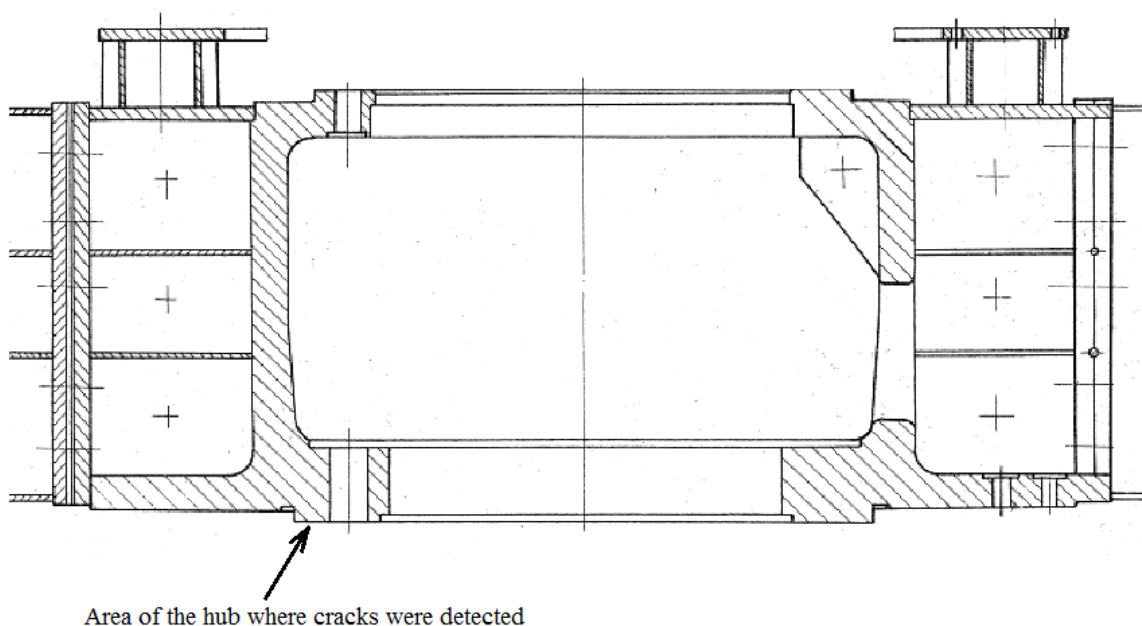
Figure 3. Generator rotor hub

Vertical Kaplan turbines are installed in 6 hydroelectric generating sets at "Djerdap 1", nominal power 200 MW, that were made in Russia [1]. They have been designed for the service life of forty years due to the structural solution, or in other words because of the impossibility of performing periodic inspections and state analyses. Basic components of the hydroelectric generating set A4 turbine are presented in figure 1, generator rotor is presented in figure 2, while casted part of the rotor hub with the marked area where cracks were detected is presented in figure 3.

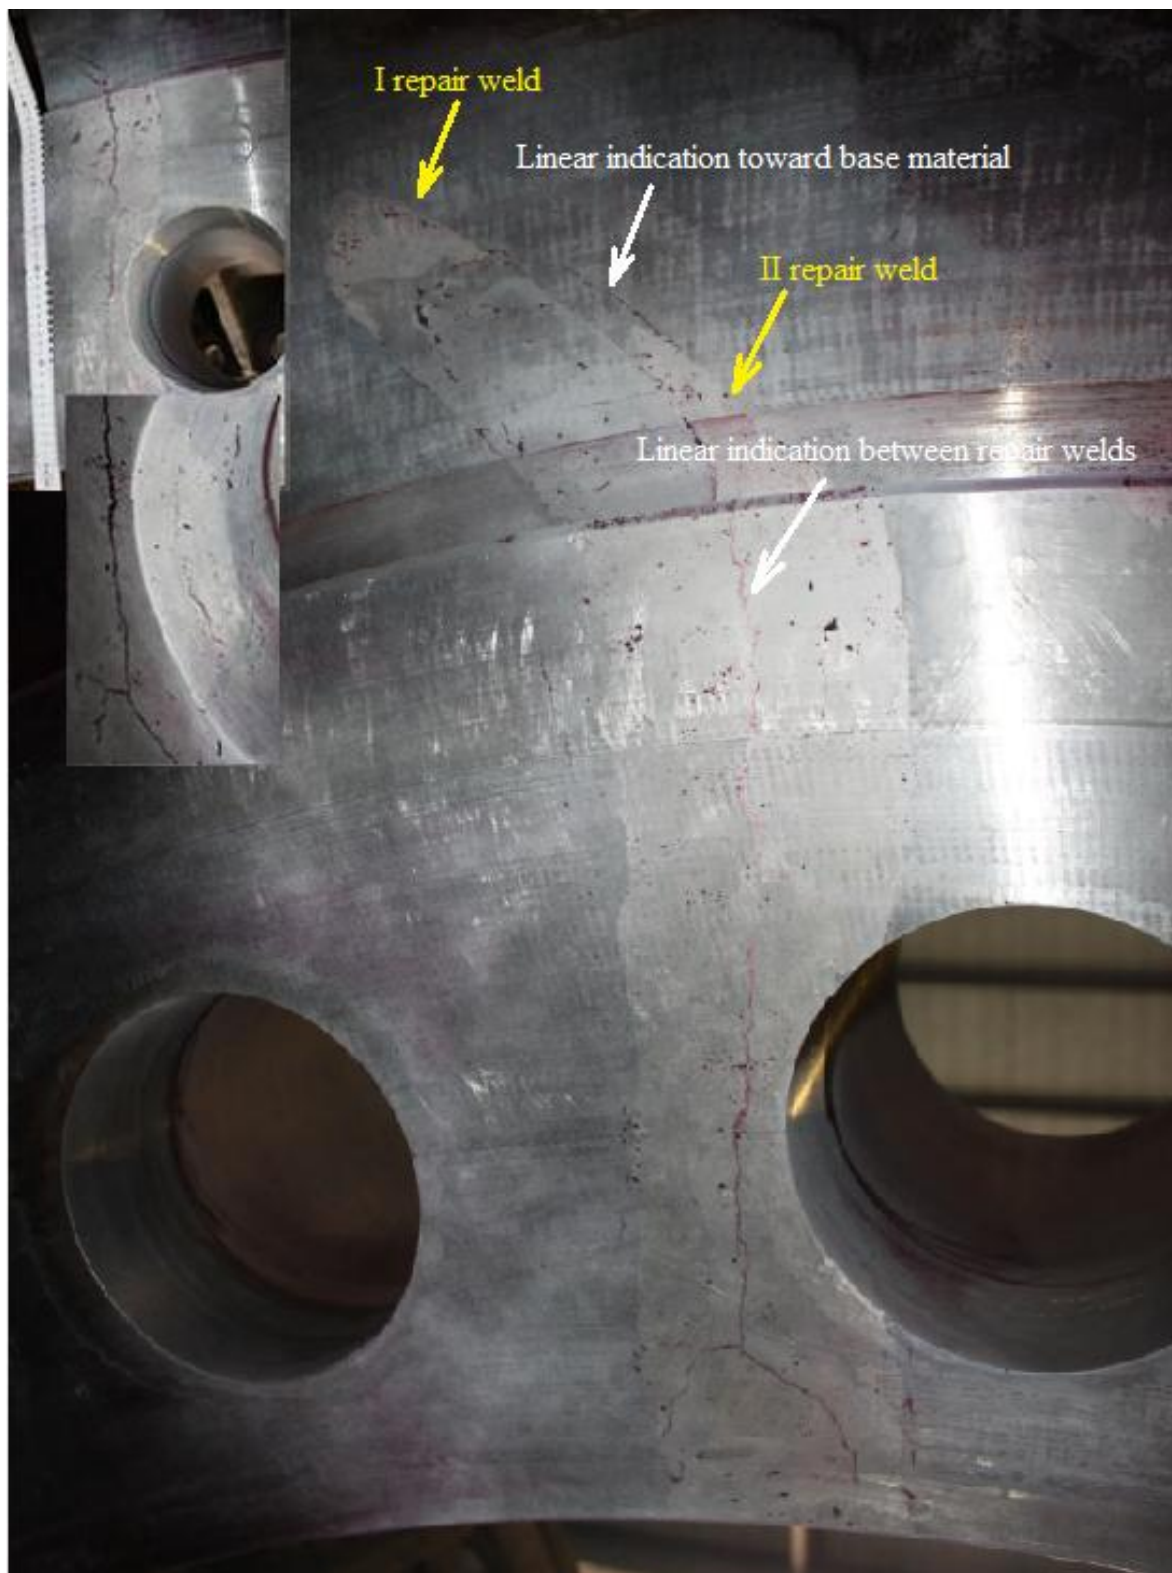
Cracks between the openings for bolts nr. 5 and 6 were detected in the area between weld metal and base material (in the heat-affected zone) and between two repair welded joints, carried out by using different kinds of austenitic filler material, figure 4. Cracks between the openings for bolts nr. 29 and 30 were detected in weld metal of the repair weld, in the transition area between the hub and the turbine shaft and between the hub and the axial bearing disc carrier, figures 5 and 6.

Figure 4. Cracks in the area between weld metal and base material of the hub, between two repair welds and between openings for bolts nr. 5 and 6

This technology of repair welding/surface welding refers to works carried out during the repair of the casted part of the generator rotor hub, at which it was necessary to perform welding / surface welding in zones where cracks were detected, depthwise and at the internal surface of the opening for the bolt nr. 5. Technology of welding/surface welding defines all activities that are supposed to be carried out before, during and after welding/surface welding. Cracks detected by visual testing, penetrant testing and magnetic particle testing were removed by grinding, figure 10.

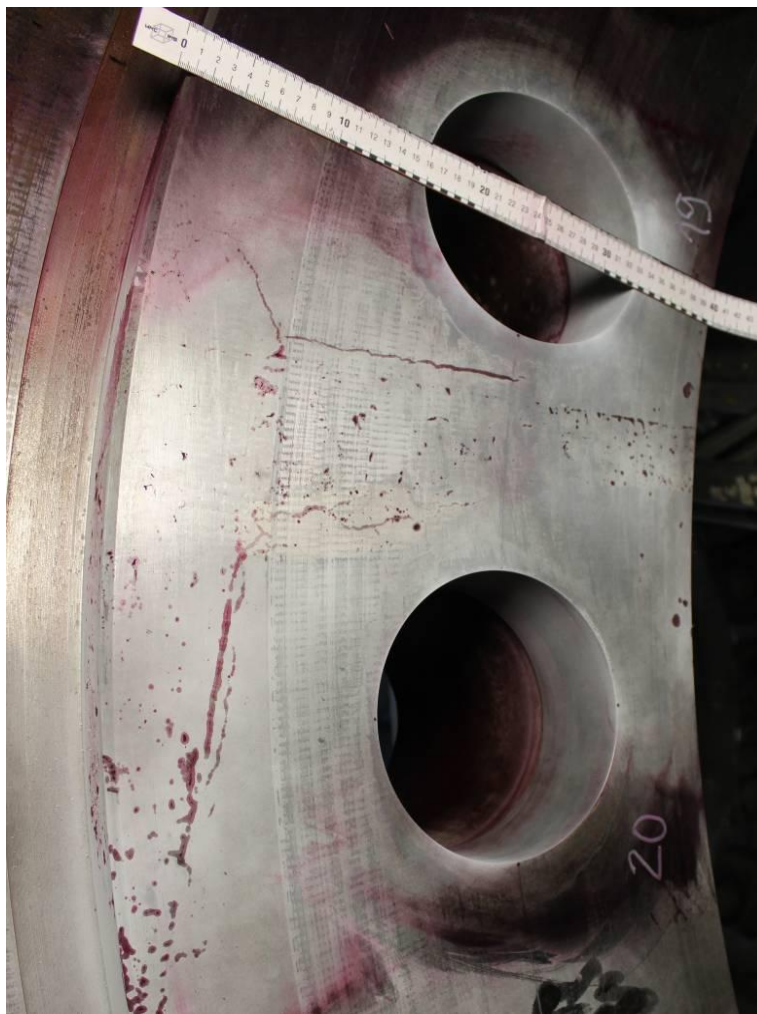
Figure 5. Cracks in the area of the repair weld (between openings for bolts nr. 19 and 20)

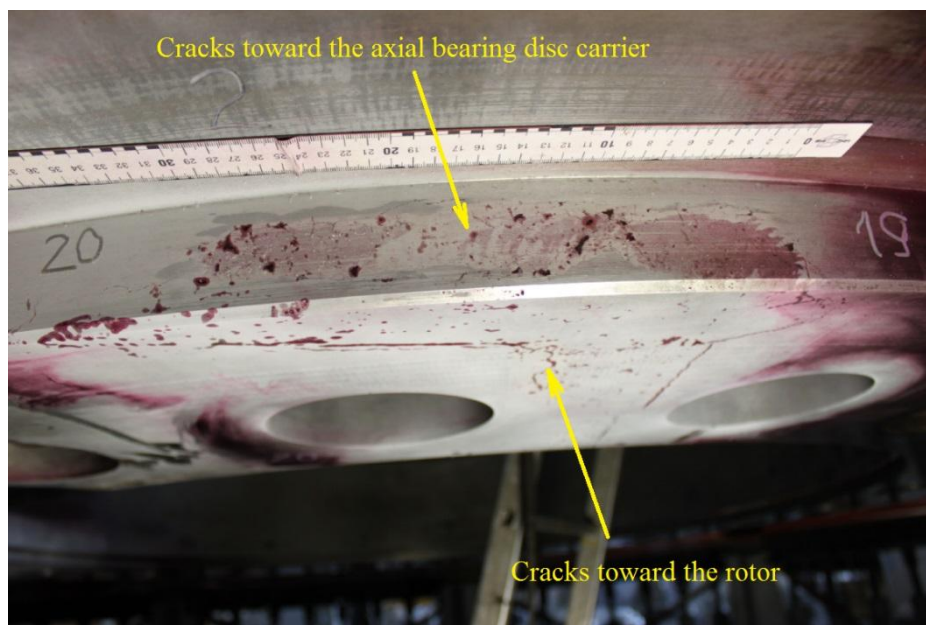
Figure 6. Cracks in the repair weld area between the hub and rotor shaft, and in the transition area from the hub toward the axial bearing (between openings for bolts nr. 19 and 20)

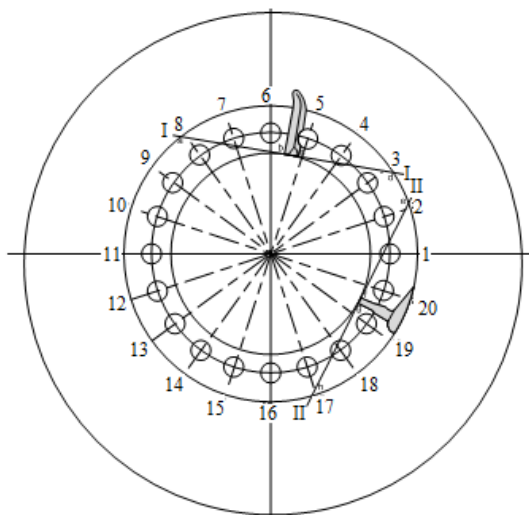
Figure 8. Planeness test for flange surface (view from below)

Inspection of surface condition regarding the deformations of the generator rotor hub (planeness test) was carried out before, during and after welding / surface welding, by positioning 2 m long ruler tangentially with respect to the internal edge of the hub flange at many locations and in areas where grinding occurred (positions I – I and II – II), which is presented in figure 8, while planeness test carried out by the measure controller is shown in figure 9. At measurement locations a, b, c and d for position I – I, as well as e, f, g and h for position II – II, the clearance was determined by measure controllers. Results of clearance measurement are presented in table 8 [5].

Ruler position	Measurement location	Date of measurement				Allowable deviation*) [mm]
		First measurement	Second measurement	Third measurement	Fourth measurement	
I – I	a					0
	b					0,03
	c					0,03
	d					0
II – II	e					0
	f					0,03
	g					0,03
	h					0
(III – III)**	i					0
	j					0,03
	k					0
(IV – IV)**	l					0
	m					0,03
	n					0
*)	For the turbine shaft flange, which is being connected with the rotor hub flange, allowable value of planeness deviance is 0,03 mm.					
**))	Ruler positions are not shown in fig. 8

In cases when planeness was unsatisfactory, the machining of hub flange was performed by achieving the parallelness with the surface of its coupling with the axial bearing disc carrier and with the surface of the flange for the connection with the turbine shaft extension;

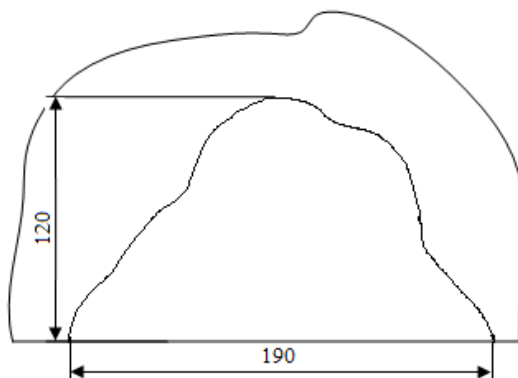
Figure 10. Appearance of the groove at the location where the deepest crack was detected

Before welding/surface welding, areas where grinding occurred were preheated by a gas flame at temperatures ranging from 120 °C to 150 °C. Butan was used for preheating, while IC thermometer was used for temperature control. After the deposition of the first weld layer preheating was no longer necessary.

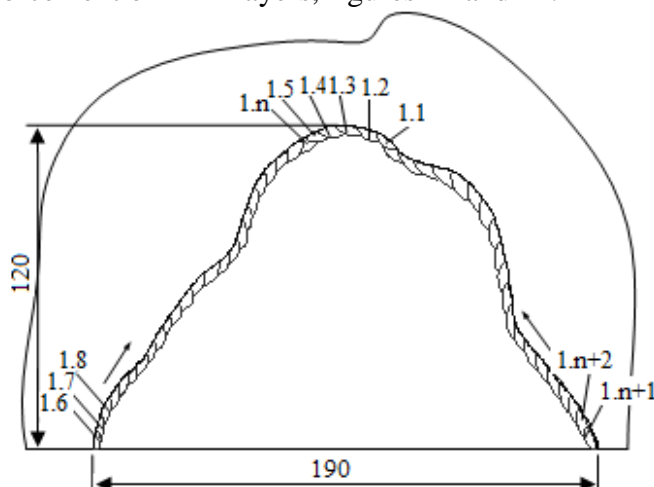
Figure 11. Sequence of welding/surface welding, deposition of the first layer

Castolin Xuper 2222 electrodes were used for welding/surface welding, diameter $d = 3.2$ mm, connected to the positive pole of direct current with intensity of 70 – 90 A. Welding/surface welding was performed by a short arc, along with the removal of slag, in the case when the width of the weld/surface weld was not higher than $2.5 \times d$. Welding/surface welding was carried out by depositing weld metal along the surface of grinded areas with the change of laying direction of 90° for every layer. After the deposition, every layer was treated by a pneumatic hammer with the rounded top. Grinding was performed on some of the layers in order to remove residual slag, sharp edges, pores etc. Filling of grinded areas was performed through the application of the overlay method with the reinforcement of 1 – 2 layers, figures 11 and 12.

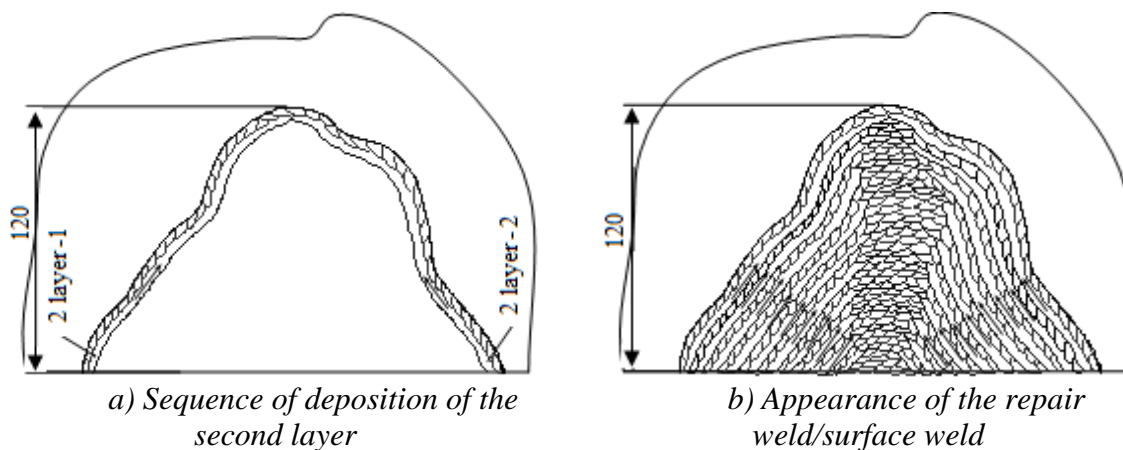
Figure 12. Sequence of deposition of the second layer and final appearance of the repair weld/surface weld
