## ANALYSIS OF CURRENT STATE AND INTEGRITY EVALUATION OF THE PIPELINE AT HYDRO POWER PLANT 'PIROT'

*Key words: hydroelectric generating set, crack, repair technology, pipeline integrity*

This paper contains the analysis of current state and integrity evaluation of the pipeline as a whole on the basis of results of non - destructive tests performed on the vital butt - welded joint in the curvature area at chainage 1+263 m (visual testing, magnetic particle testing, penetrant testing, ultrasonic testing, radiographic testing, metallographic replication testing).

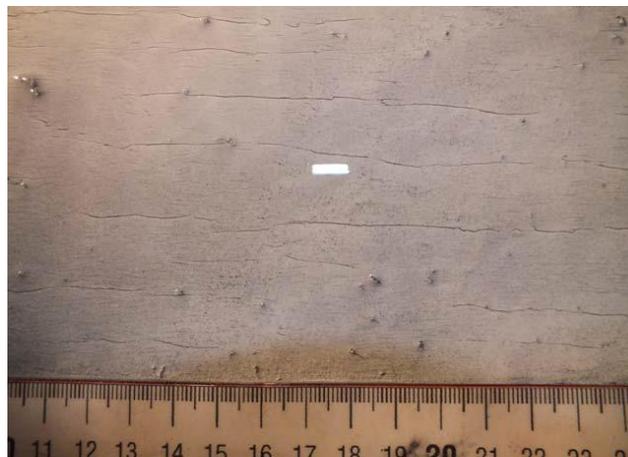
Nevertheless, in the lower zone of the internal pipeline surface the linear indications (cracks) were detected only at the surface of parent material. The deepest crack was 2,5 mm deep, while crack lengths vary. Length of the largest crack, located along the circumference of the parent material, was 540 mm (figure 4).

*Figure 4. Appearance of a segment of the examined surface of parent material along the circumference of the vital butt-welded joint*

Cracks at the surface of parent material were eliminated by fine grinding, while repair welding/surface welding had to be performed in areas at the surface of weld metal where cracks were detected after the grinding was finished through the utilization of welding procedure 111 with electrode EVB 50 (Jesenice electrodes), classified in accordance with the adequate standard [9]. Chemical composition of weld metal is presented in table 3, while mechanical properties are presented in table 4.

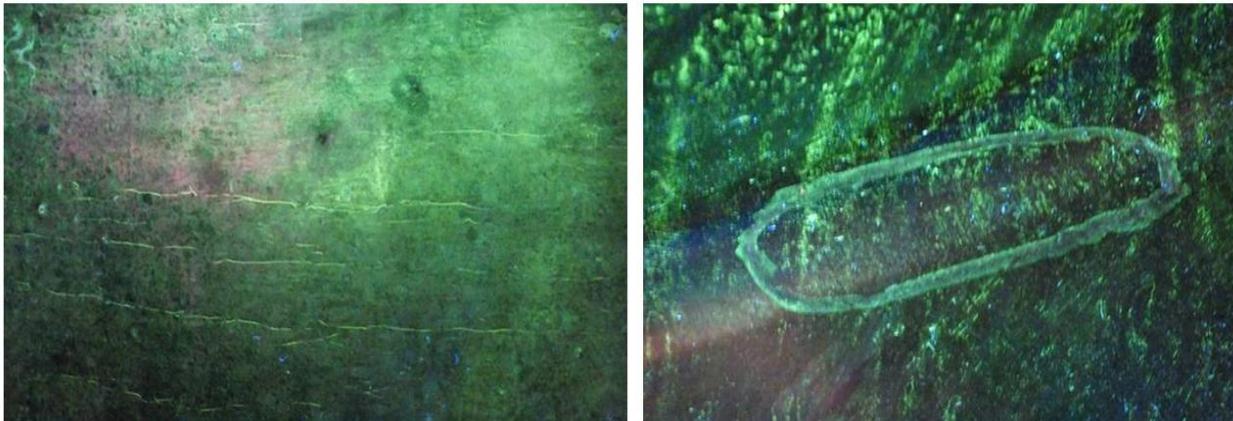
a) Appearance of surface cracks  
on the surface of parent material

b) Appearance of surface cracks  
on the surface of weld metal

*Figure 5. Appearance of magnetic particle testing performed on the welded joint,  
at the external surface of the pipeline*

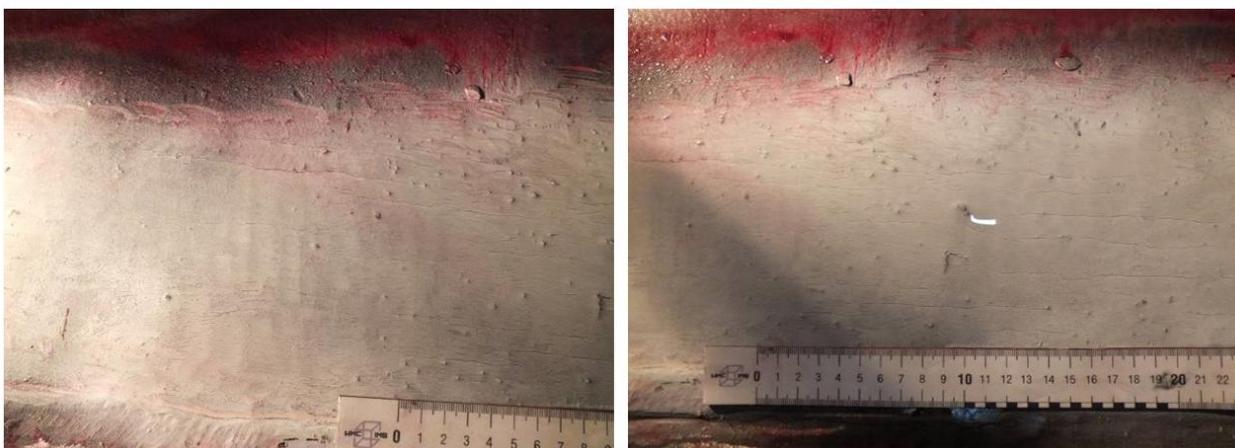
a) Appearance of the crack at the surface  
of the heat-affected zone

b) Appearance of cracks at the surface  
of parent material

*Figure 6. Appearance of penetrant testing performed on the welded joint,  
at the external surface of the pipeline*

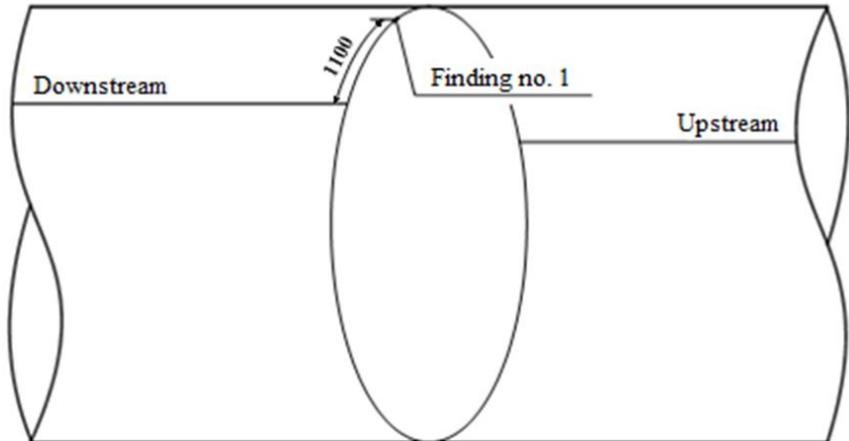
Ultrasonic testing was performed on parent material and weld metal [6] in order to determine depths of surface cracks. It was determined that cracks in parent material are 1,5-2,5 mm deep, while cracks in weld metal are 3,5 - 10,0 mm deep. Process of ultrasonic testing of the butt - welded joint, as well as location of the 10 mm deep surface crack are presented in figure 7.

b) Location of the 10 mm deep surface crack in the area of the butt - welded joint

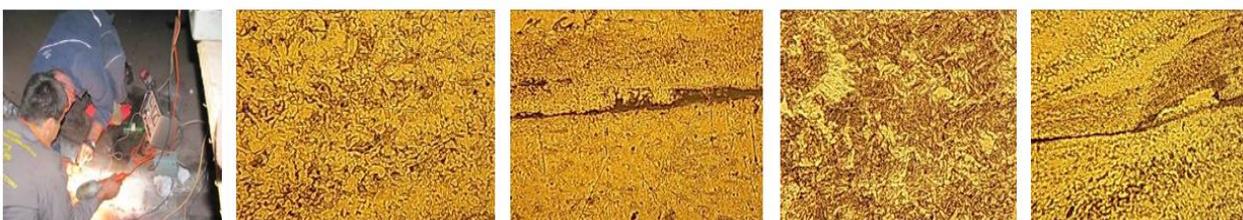
Test results showed that the microstructure of the surface layer is ferrite-pearlite with small non-metallic inclusions and corrosion products present, as well as 12 - 15 mm long macrocracks. Test results also showed that the microstructure of weld metal is coarse grained ferrite-pearlite with small non-metallic inclusions and corrosion products present, as well as 30-35 mm long macrocracks. Characteristic test results are presented in figure 8.

**Figure 8.** Appearance of characteristic results of metallographic replication testing
