REPAIR OF DAMAGES DETECTED AT THE SHAFT AND VENTILATION RING VANES OF THE HYDROELECTRIC GENERATING SET A2 GENERATOR AT THE HYDRO POWER PLANT 'PIROT'

Miodrag Arsić, Srđan Bošnjak, Vencislav Grabulov, Nebojša Milovanović, Milan Minić,
Zoran Savić

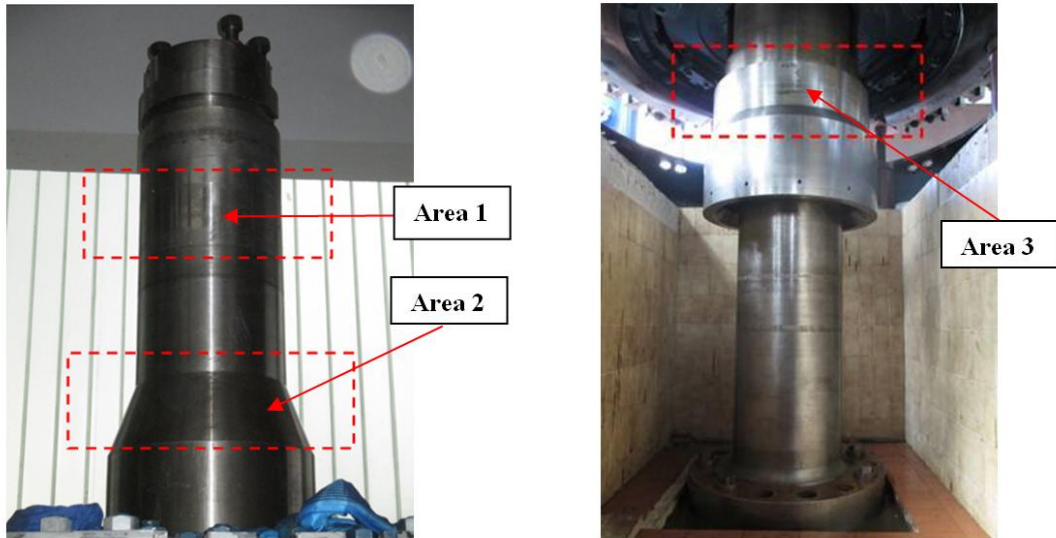
In figures 2 and 3 the mechanical damages detected at the upper and lower section of the generator shaft are shown. By dimensional checks it was determined that damages at the shaft are not more than 2 mm deep.

a) Appearance of mechanical damages detected at the upper section of the generator shaft

b) Appearance of mechanical damages detected at the lower section of the generator shaft

Figure 2. Appearance of mechanical damages detected at the upper and lower section of the generator shaft

On the basis of the analytical and numerical calculation of the generator shaft with mechanical damages it was determined that its repair could be performed only by fine grinding.

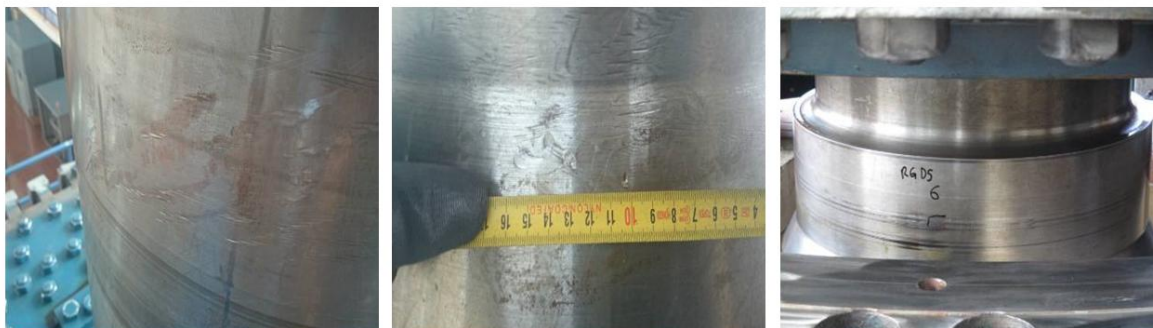
a) Appearance of mechanical damages in area 1

b) Appearance of mechanical damages in area 2

c) Appearance of mechanical damages in area 3

Figure 3. Detailed appearance of damages detected at the upper and lower section of the generator shaft

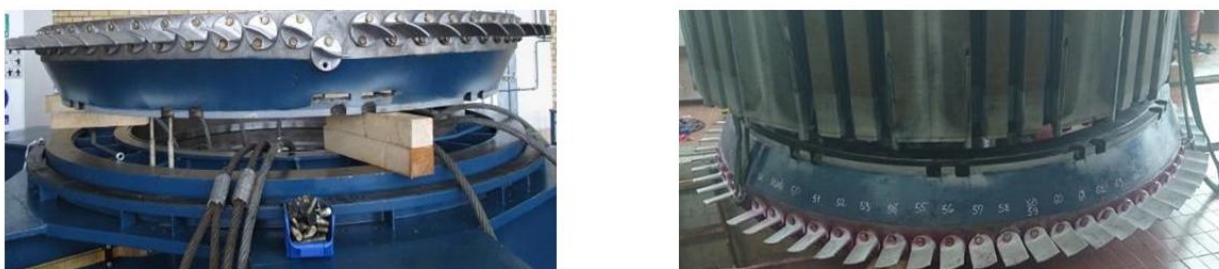
Damages detected at the vanes of upper and lower ventilation ring for air cooling of the generator rotor are shown in figure 4. Corrosion, erosion and, most of all, cavitation damages at vanes, up to 1 mm deep, were detected by penetrant testing, figure 5.

a) Upper row of ventilation ring vanes

a) Lower row of ventilation ring vanes

Figure 4. Appearance of mechanical damages detected at the upper and lower row of ventilation ring vanes

- Areas at vanes where corrosion, erosion and (most of all) cavitation damages were detected, were locally pre-heated at 150°C after the preparation was performed by angular and frontal grinder;
- Welding/surface welding was performed through the use of electrode OK 68.17 with 2.5 mm diameter
- After welding/surface welding was performed, vanes were additionally heated at 150°C for an hour; then isolated from both sides and slowly air-cooled;
- After the repair of areas where mechanical damages were detected by welding/surface welding was performed, welds were finely grinded by angular and frontal grinders in order to obtain adequate geometry and surface roughness.

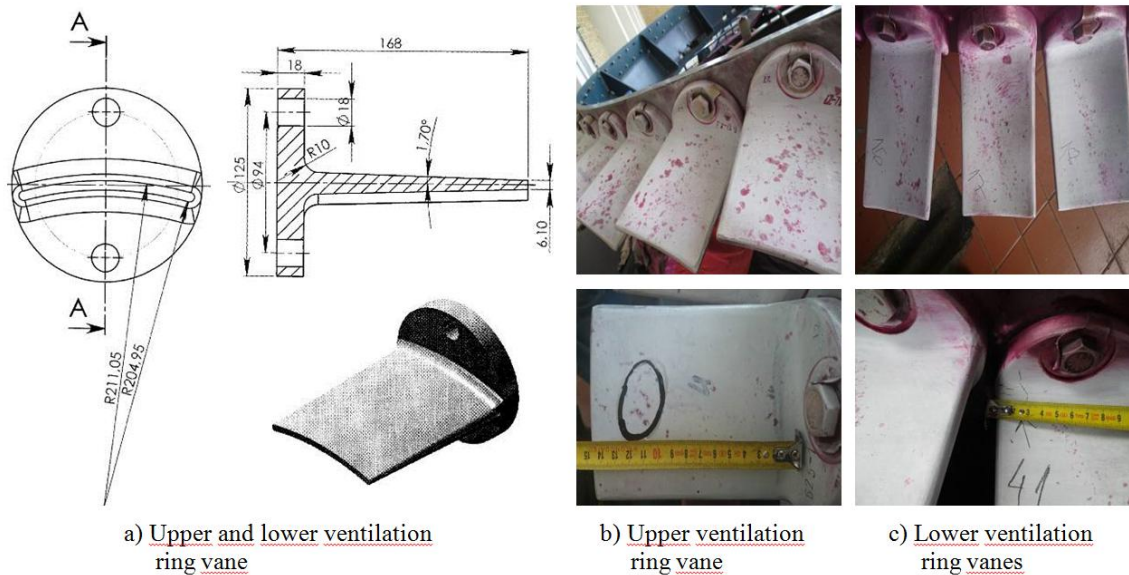
Figure 5. Corrosion and cavitation damages detected at the upper and lower ventilation ring vanes
