## TEHNOLOGIJA REPARATURNOG NAVARIVANJA NOŽEVA PLUGA ZA ČIŠĆENJE SNEGA

## TECHNOLOGY FOR REPARATORY HARD FACING OF SNOW PLOUGH BLADES

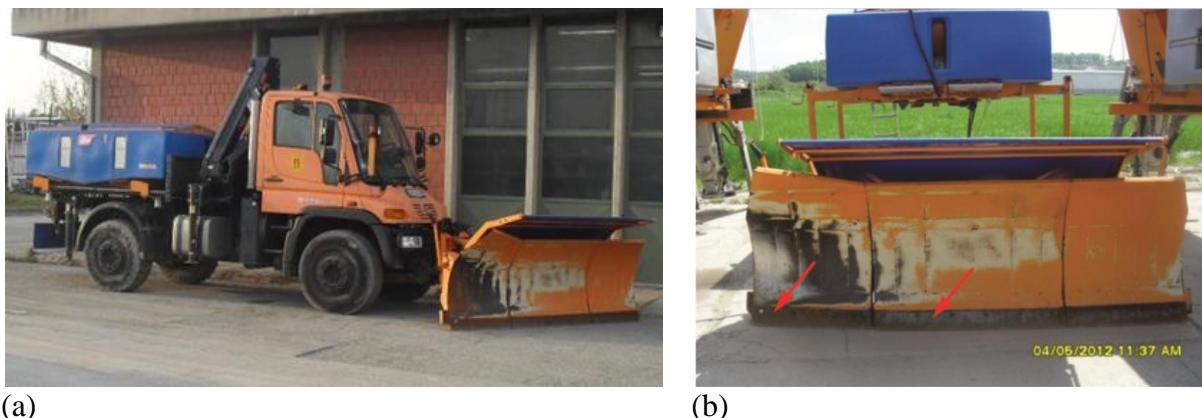
Plug za čišćenje snega montira se na prednji kraj radne mašine ili vozila, a sneg sa kolovoza se sklanja mehanički guranjem. Hidraulični sistem omogućava rukovanje (manipulaciju) ovim uredjajem i služi za njegovo podizanje, spuštanje i zakošenje pod odgovarajućim uglom. Sistem zaštite omogućava da se pri iznenadnom udaru u neku prepreku na putu plug podigne ili zaokrene pod određenim uglom, što omogućava hidraulični sistem, ili mehanički sistem pomoću opruga. Na slici 1(a) prikazan je izgled plugova montiranih na radne mašine i vozila spremnih za rad. Na slici 1(b) se jasno vidi raspodela intenziteta habanja po čitavoj njegovoj širini kao i karakterističan način habanja.

*Slika 1. (a) Vozilo za čišćenje snega i (b) pohabani noževi pluga.  
Figure 1. (a) Snow plough vehicle and (b) worn plough blades.*

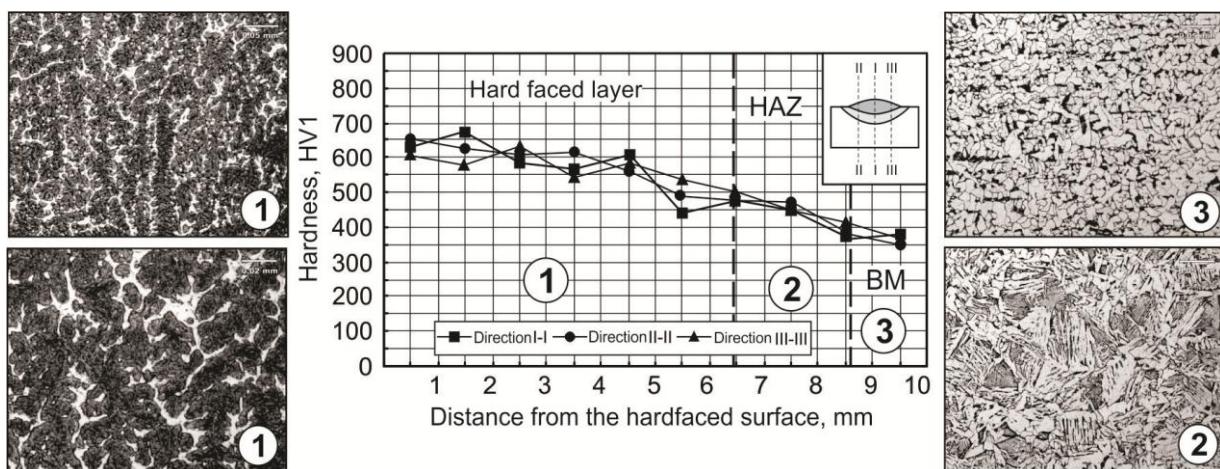
Mikrostrukture površine i zona navarenih slojeva su procenjene kao: 1 – FM – martenzitno-karbidska sa zaostalim austenitom, 2 – ZUT – grubozrna, 3 – BM – perlitno-feritna struktura.

*Slika 3. Tvrdoća i mikrostruktura navarenog sloja.  
Figure 3. Hardness and microstructure of the hard faced layer.*

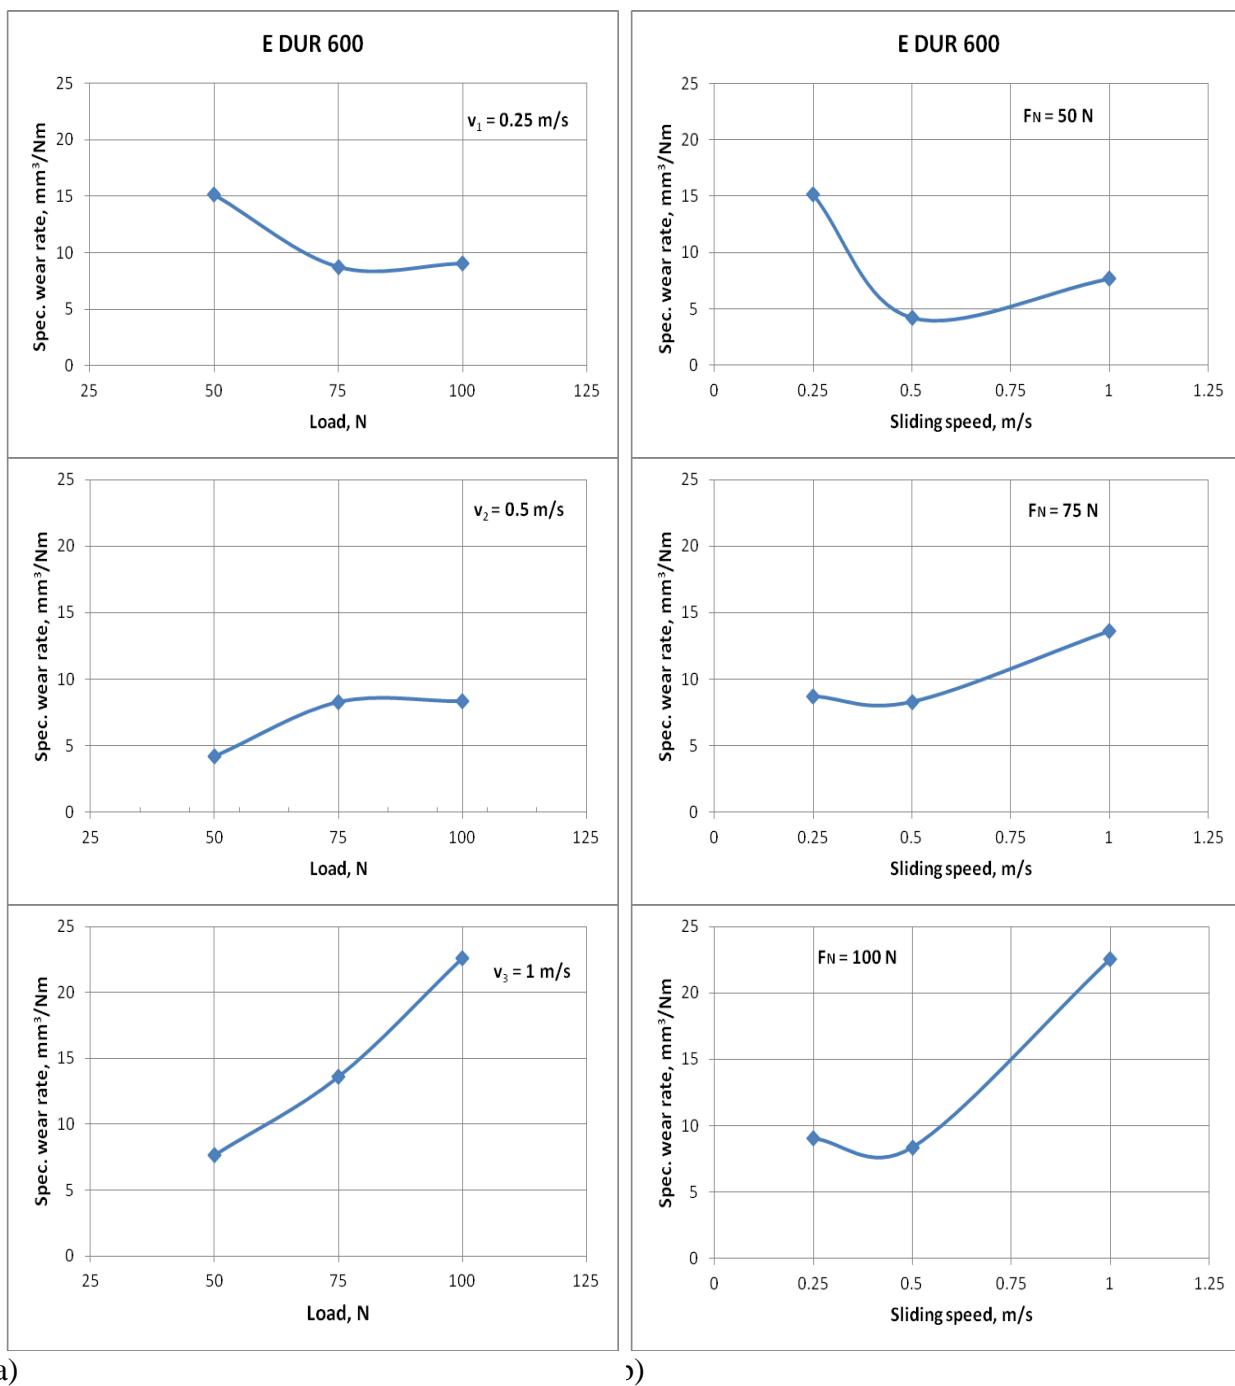
*Slika 5. Specifična brzina habanja uzoraka: (a) pri različitim brzinama klizanja i (b) pri različitim opterećenjima.*

Takodje, u prilog ovom dodatnom materijalu idu i laboratorijska ispitivanja tvrdoće i mikrostrukture kao i otpornosti na habanje. Dobijeni rezultati pokazuju da su najkritičnije brzine klizanja, koje prouzrokuju najveći intenzitet habanja, brzine od 0.5 i 1 m/s. Stoga je preporuka da se delovi navareni ovim dodatnim materijalom eksploratišu u uslovima manjih brzina (< 0.5 m/s).

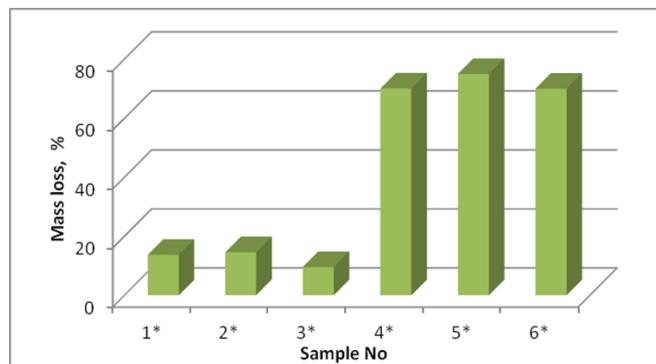
Otpornost na habanje je određivana na osnovu gubitka mase materijala ispitivanih uzoraka noževa posle 140 h efektivnog rada. Vizuelno je bilo moguće da se uoči velika razlika u širini noževa posle ispitivanja, pa se merenjem linijske pohabanosti došlo do saznanja o višestruko većoj otpornosti na habanje navarenih od nenavarenih noževa. Međutim, zbog neujednačenosti pohabanosti kontaktne površine po čitavoj dužini noževa, otpornost na habanje ispitivanih noževa je određivana merenjem mase pre i posle ispitivanja. Rezultati ovih istraživanja su dati u tablici 3 i na slici 6.

*Slika 6. Histogramski prikaz otpornosti na habanje noževa pluga za čišćenje snega posle 140 h rada.*

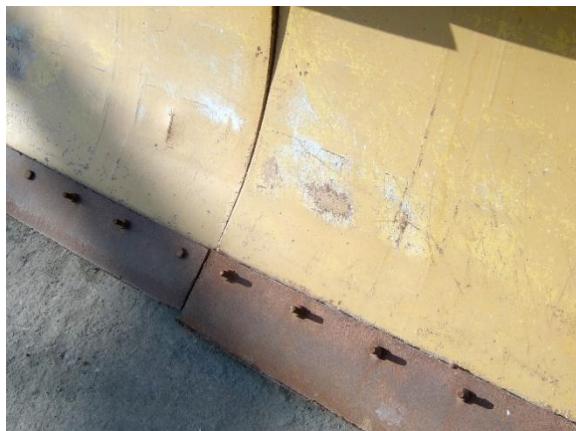
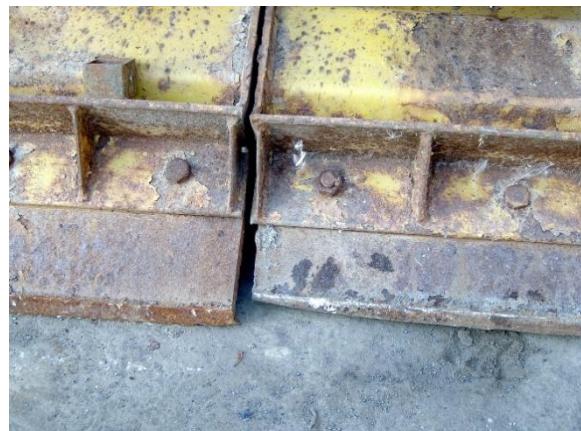
Praćenje habanja noževa pluga za čišćenje snega izvedeno je dosta jednostavno, i to za tri slučaja. U prvom slučaju praćeno je habanje na naoštrenom novom i navarenom nožu. Nož navaren na plug je pričvršćen pomoću zavrtnjeva i navrtki na desni segment pluga, a nenavaren nož je na isti način pričvršćen na levi segment pluga. Razlog za ovo je činjenica da je nož koji čisti ivicu puta izložen intenzivnijem habanju pa se više haba, što je bio razlog za rigorozniju proveru otpornosti na habanje u radnim uslovima. Takođe, na osnovu iskustva, utvrdjeno je da je radni vek nenavarenih noževa izradjenih od C 45 (Č1530) oko 150 h efektivnog rada. U drugom slučaju ispitivani su nenaotstreni noževi, jedan navaren i jedan nenavaren, koji su montirani na isti način kao i u prvom slučaju. U trećem slučaju zamjenjena su mesta montaže navarenog i nenavarenog noža, tako da nenavaren nož čisti ivicu, a navaren nož sredinu puta. Na slici 7 su prikazani navareni i nenavareni noževi posle eksploracije.

*Slika 7. Pohabanost nenavarenih i navarenih noževa pluga za čišćenje snega: (a) prednja i (b) zadnja strana noževa.*

Na osnovu izvedenih ispitivanja utvrdjeno je da maksimalna širina noža koja se u toku eksploracije može pohabati, a da ne dodje do oštećenja noževa, iznosi oko 150 mm. Na kraju ispitivanja moglo se utvrditi da je gubitak materijala kod nenavarenih noževa po širini u proseku oko 120 mm, a kod navarenih noževa pohabana širina je oko 20 mm, što je približno jednak

debljini navarenog materijala. To navodi na zaključak da je otpornost na habanje navara dodatnog materijala E DUR 600, pri ovim radnim uslovima, najmanje pet puta veća od otpornosti na habanje osnovnog materijala, za sve slučajeve izvedenih ispitivanja. Primenom proizvodnog navarivanja radni vek ovih noževa može se višestruko produžiti. Takodje, pohabani noževi se mogu i obnoviti reparturnim navarivanjem, čime se njihov radni vek dodatno može produžiti, ali se zbog tehnološke isplativosti preporučuje blagovremena reparatura, odnosno, dok njihova pohabanost po širini ne predje 20 mm.
