INVESTIGATION OF MICROSTRUCTURAL AND MECHANICAL PROPERTIES OF SUBMITTED WELDED PARTS – PULLING PIPES

Sveto Cvetkovski¹, Vencislav Grabulov², Nazif Jashari³

Faculty of Technology and metallurgy, Skopje Republic of Macedonia¹

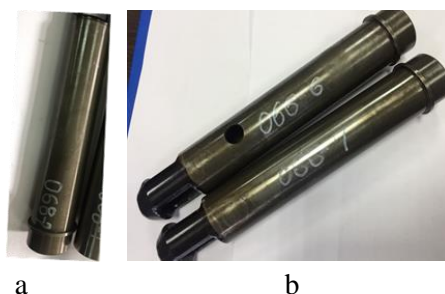
This technical report was prepared on the request of the welding company for the production parts for the railway vehicles. The main reason for the investigation is checking the quality of the welded joint (pulling pipe) because there was suspicion of the wrong base material of one welded piece was used (pipe). Welded joint consists of the two parts, pipe and forged part. This welded part is called pulling pipe (Figure 1) after welding the part was subjected to surface treating namely browning. It was detected that the color of the parts after browning is quite different although both part should be made from the same material. Because of that there was a suspicion that the material of pipe is not S355 steel, probably some alloyed steel.

Figure 1. a.) piece of pipe b.) welded pulling pipe

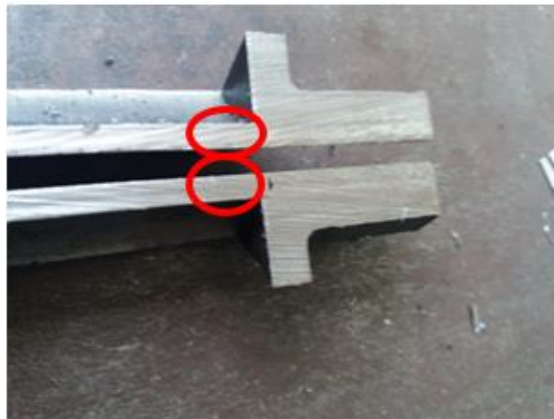
This type of investigations should discover which is maximal tensile force which could be standing out by pulling pipe. For such investigation was predicted doing of the round tensile probe. But during machining the probe welding defects were detected, figure 3. Because of that was decided to make tensile test of the complete pulling pipe (technological probe). Two probes were exterminated and results of investigations are given in the table 2. According information's from the designing department, tensile force should be 3 tons. It can be concluded that this condition is fulfilled, because obtained values for the tehstile probes were more than nine tones.

Figure 3. Lack of penetration

Beveling of the pipe edges supsupress welding defects like lack of penetration

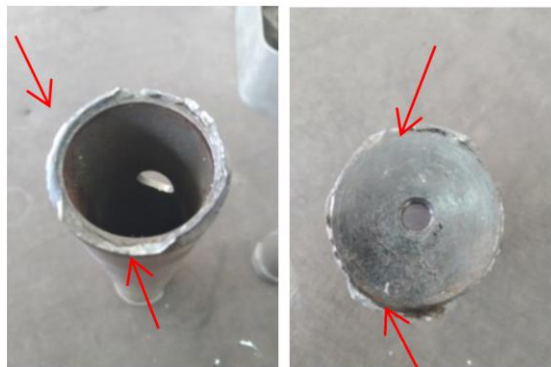
Figure 4 shows broken surface of the pulling pipe. It is visible that fracture appears through welded joints which consist of two welds. Deformation of the broken surface is not uniform around the volume.

Figure 4. Fracture of the pulling pipe as result of the tensile testing

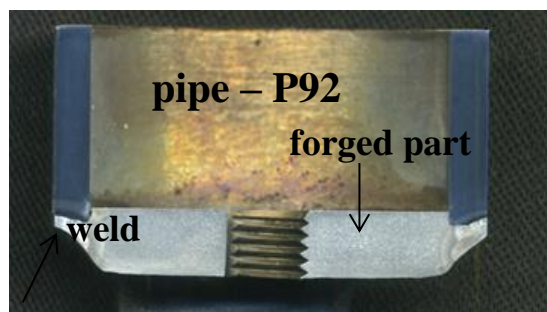
Prepared macro-metallographic specimen is shown at the figure 5. It is clearly seen from the macro specimen that Nital etches only forged part made of S355 steel, but pipe made of ferritic steel P92 is not etched. It can be seen from the figure 5 that welding was performed with two passes. Micro-metallographic investigations didn't discover some welding defects.

Figure 5. Macro specimen of the welded joint

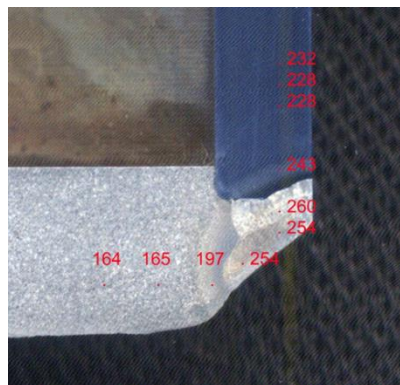
Hardness measurement was performed on the metallographic specimens (figure 6). Vickers method was implemented in this investigation. The lowest hardness values has pipe produced from S355 structural steel i.e. 165HV (base material). The hardness of HAZ is much higher and has value of 197 HV. The hardness of the ferric steel is 230 HV which is the highest measured value. It's in accordance with our assumption because this steel (pipe) contains chromium and molybdenum. Hardness in HAZ is even higher and has value of 243. Probably the pipe was normalized before use. Dendritic microstructure of the weldmet has the highest hardness of 260 HV. Both welded parts have the highest microstructure in the HAZ.

Figure 6. Hardness measurements in the welded joint

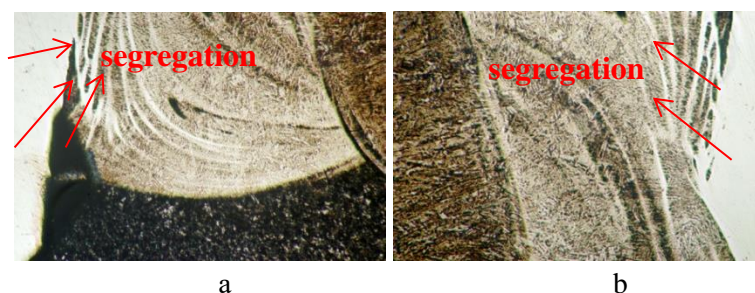
From the micro-metallographic picture, figure 7 could be concluded that there is distinct segregation in the weld metal as result of big difference in the chemical composition between high alloyed base metal (ferritin steel with Cr and Mo) and no alloyed filler material. .

Figure 7. Segregation in the weld metal

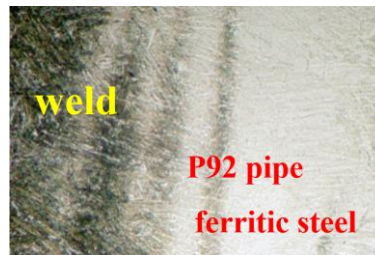
Figure 8 show segregation between the pipe P92 and unalloyed weld metal G3Si1. Figure 9 presents transition region between forged part and weld metal. There is no segregation in this case.

Figure 8. Transition region between weld metal (G3Si1) and P92 pipe

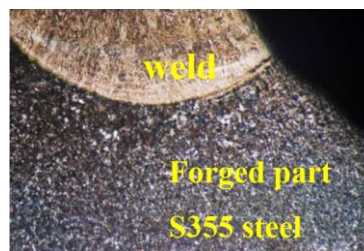
Figure 9. Welded joint between forging part S355 and G3Si1 filler metal

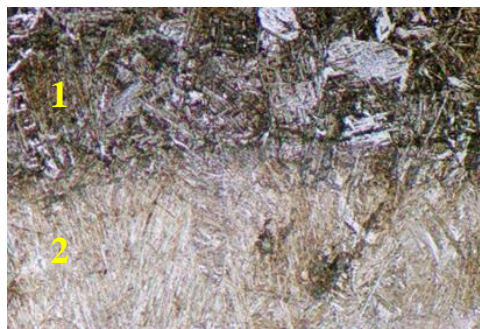
From the figure 10 can be see microstructure of the two passes. It is beinitic martensitic microstructure which has high hardness value.

Figure 10. Microstructure of the weld passes

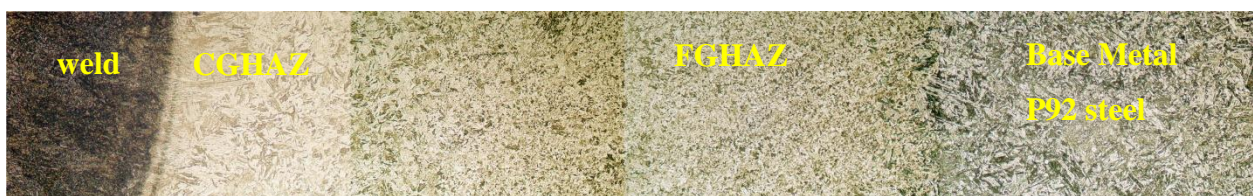
Figure 11 show microstructure of the complete welded joint starting from the weld metal towards the coarse engrained HAZ, fine grained HAZ and base metal feritic P92 steel. Etching was done with oxalic acid.

Figure 11. Microstructure of the welded joint

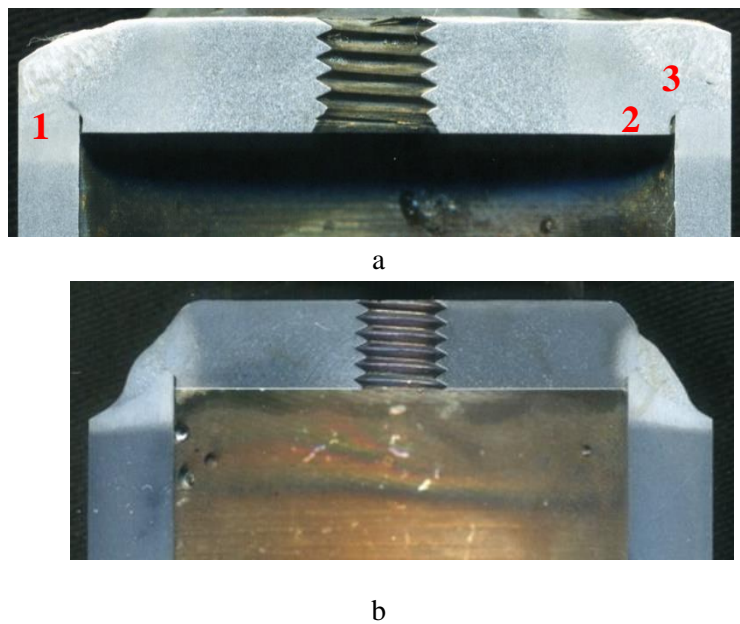
Figure 12a presents macrostructure of the welded joint formed between forged part and pipe, both of them from S355 steel. In this case proper base material was used. But in this case another problem appears. The two cracks and incomplete fusion between welding passes appeared in the welded joint. Defects are denoted with red numbers in the figure 12. It is obvious that cracks appeared as results of big distance between forging part and pipe. Besides, as result of type of joint pipe edges are not beveled. Figure 13 presents macro photo after beveling of pipe. It can be seen that situation is much better, and defects in the welded joint didn't appeared.

Figure 12. Micro photo of the welded joint a. without beveling b. after beveling.

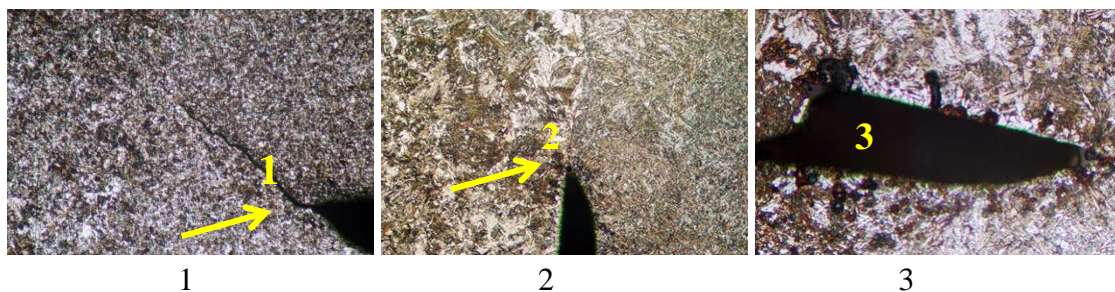
The figure 13.1 show the microstructure immediately to the cracks number 1. It can be clearly seen the point where the crack starts Microstructure in the vicinity of the crack number 2 is shown in the next figure 13.2. And lack of fusion is between two passes is shown in the figure 13.3

Figure 13. Crack 1 Defects in the welded joint
