CAUSE OF LAMELLAR TEARING OF PARENT MATERIAL AND DEGRADATION OF WELDED JOINTS AT VITAL WELDED STRUCTURES OF THE TURBINE AT HYDRO POWER PLANT ‘ĐERDAP 1’

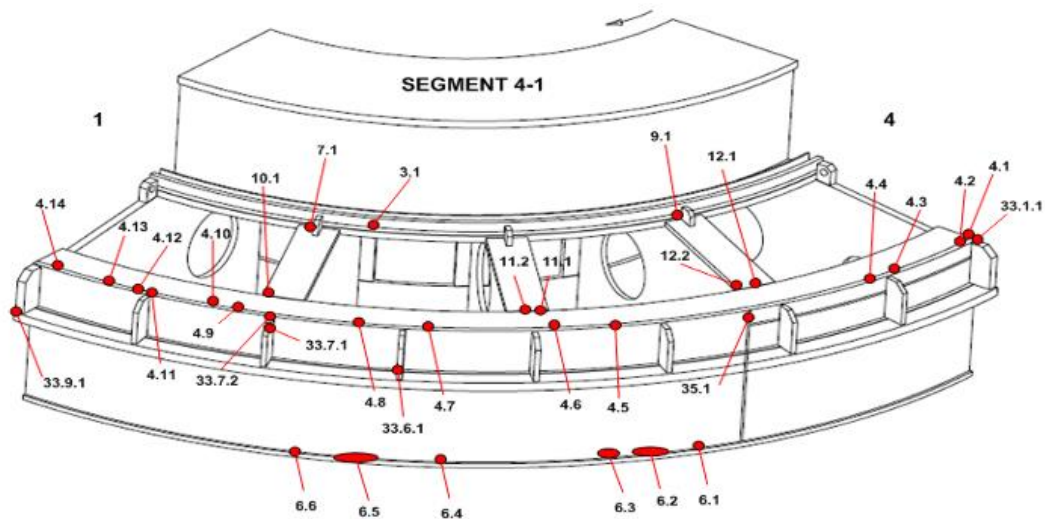
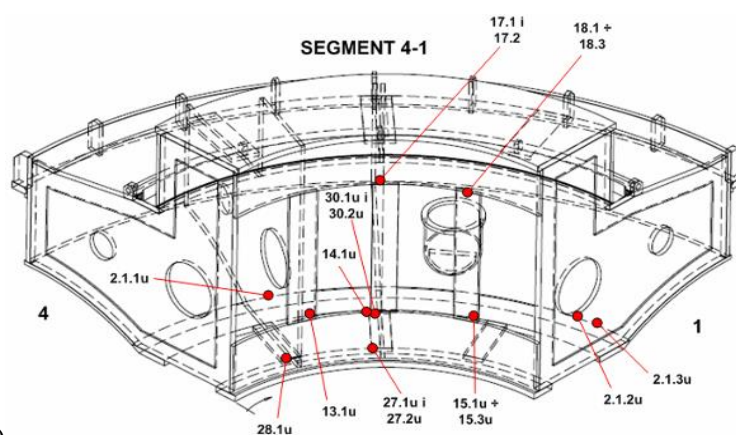
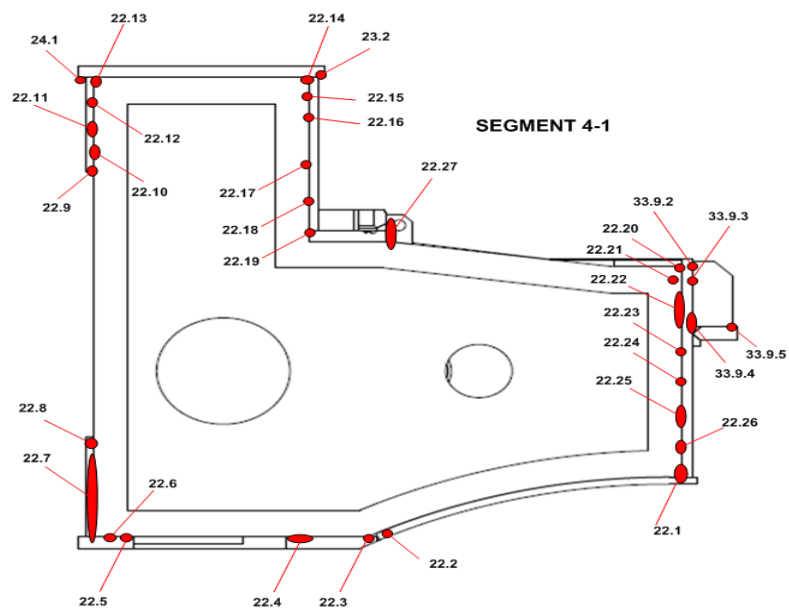
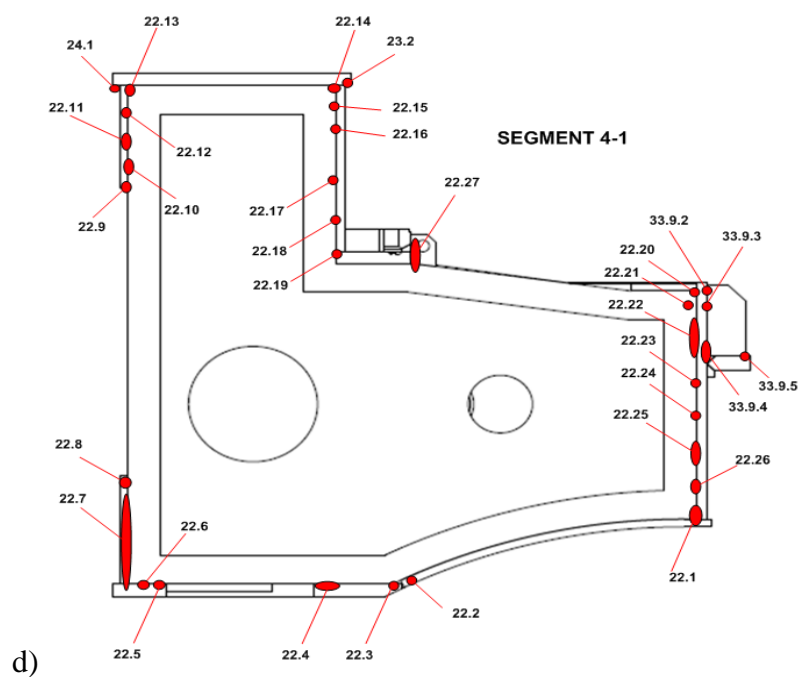
Figure 4. Locations of surface defects detected by magnetic particle testing
at a segment of the turbine cover

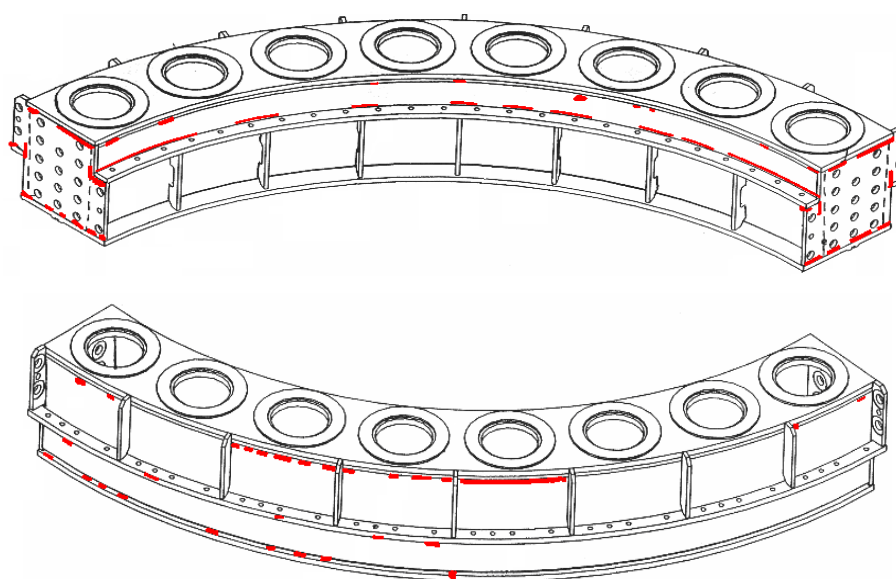
Figure 5. Locations of surface defects detected by magnetic particle testing
at a segment of the upper ring of guide vane apparatus

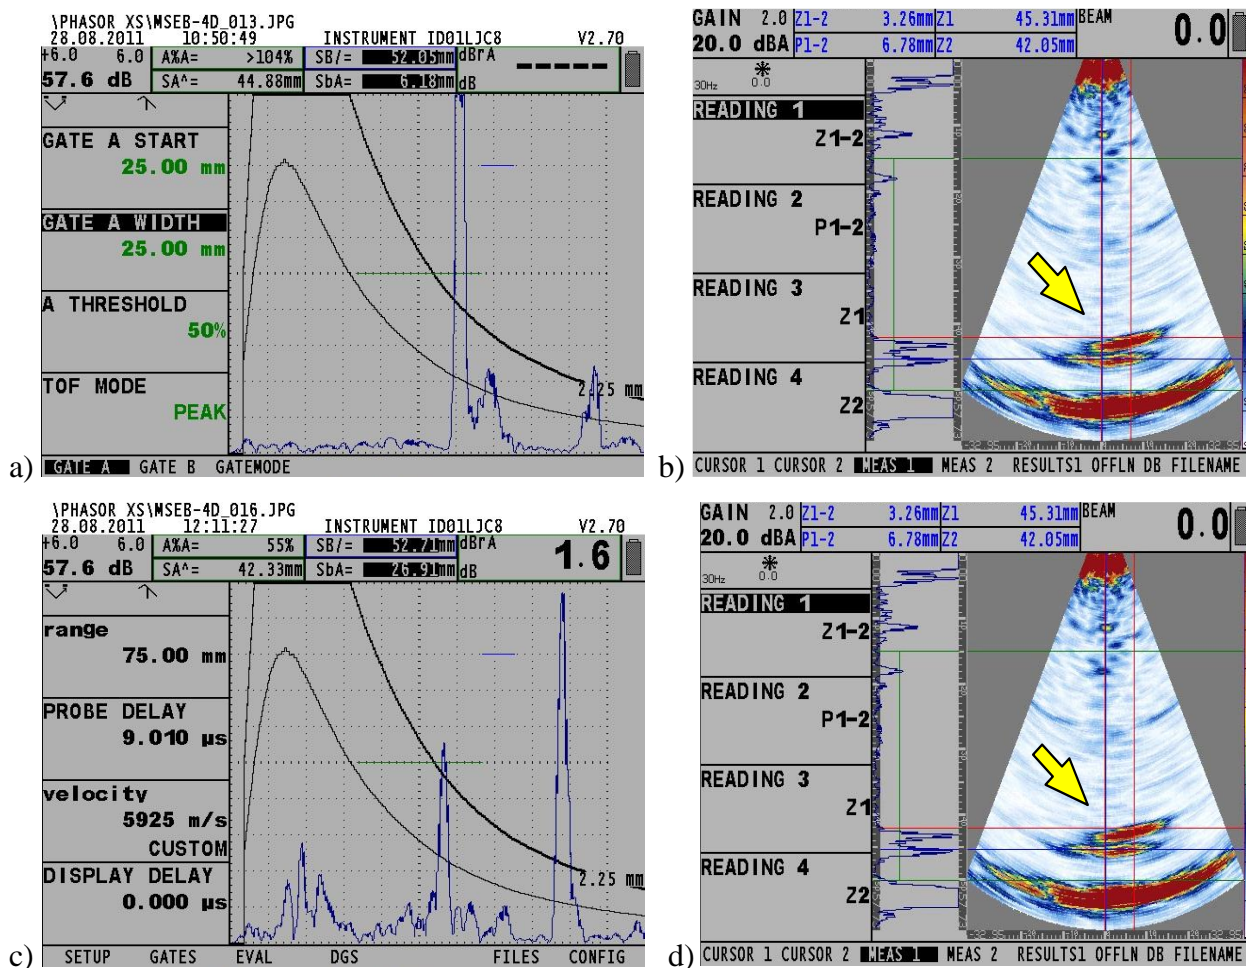
Figure 7. Echographs of indications of lamellar tearing of parent metal in the area of welded joints of the upper ring of guide vane apparatus (detected by ultrasonic testing)

On the basis of results of experimental and theoretical researches associated with lamellar tearing it was concluded that welded structure of the turbine cover of the hydroelectric generating set A4 at hydro power plant 'Djerdap 1' is an example of a situation when 2 equally significant causes of degradation of parent material and weld metal exist, which are:

- degradation caused by a flaw in steel production technology,
- degradation caused by a flaw in technology which refers to the execution of a welded structure.
