# INFLUENCE OF Cr CONTENT IN STEEL 12X1MF ON EXPLOITATION LIFE OF SUPERHEATER PIPES

Filip Zdraveski<sup>1</sup>, Dobre Runchev<sup>2</sup>

<sup>1,2</sup> Faculty of mech. engineering–Skopje, Department for welding and welded structures, UKIM

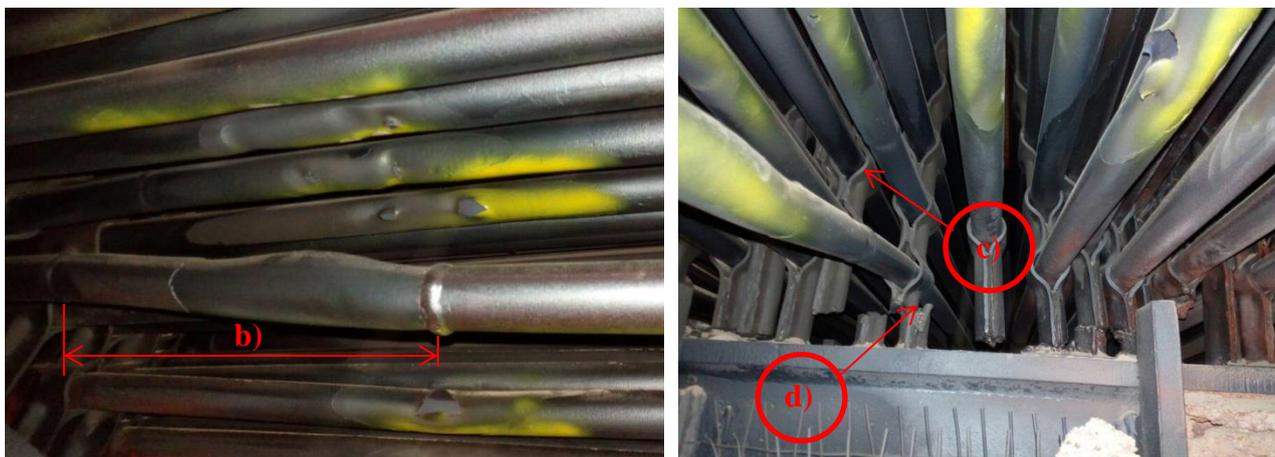
- a) Location of explosion
- b) Failure segment (cc.300 mm)
- c) Tolerance between holder and tubes
- d) Unsupported (unrestrained) tube holders
- e) Side damage from explosion (yellow)

Figure 9. Location and restrains of failure tube segment

Fig.9 clearly shows that it is newer segment that was installed later as replacement because of abrasion. From the surrounding area of exploded tube it is seen that there are no conditions for restricting the dilatation of tubes which can be considered as one possible reason that leads to increased stress and premature creep aging rupture.

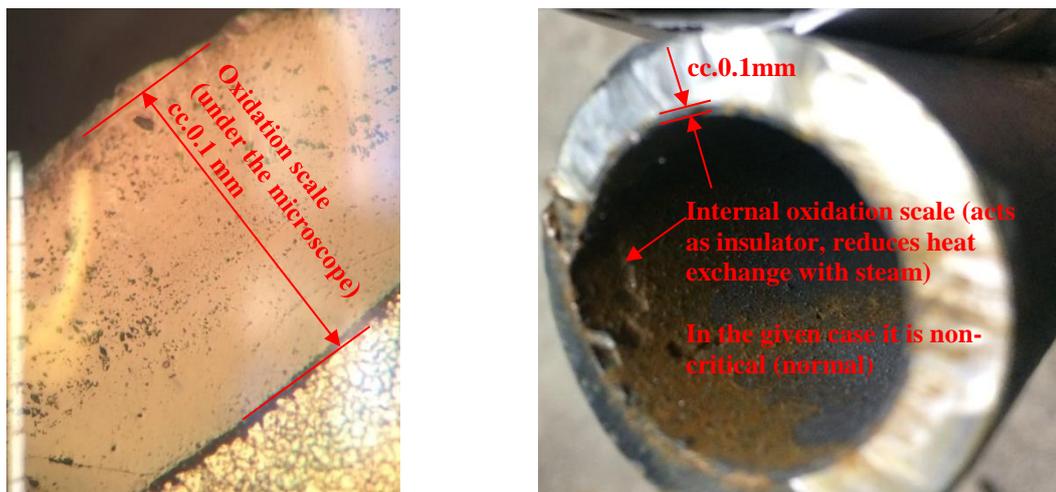
Figure 12. Oxide scale (non critical thickness)

within normal limits, have not yet experienced such a failure. Fig.12 shows that there are no conditioning problems with the steam that can lead to additional thermal overload of the tubes.

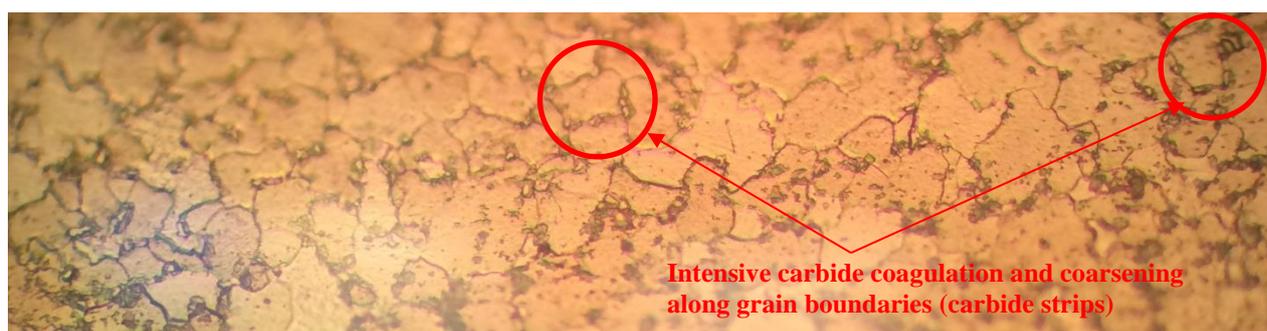
x200

x500

Figure 13. Ferritic-carbide mixture, 80% degraded microstructure of investigated tube

The microstructure presented in fig.13 confirms the above explained. Namely, it is a steel that had original un-acceptable microstructure class 6, below 15% sorbite [6]. There are no traces of tempered bainite microstructure (sorbite), which is not the case with surrounding pipes with similar wall thicknesses and much longer exploitation life.

The shape of the accumulated boundary carbides in fig.13 and having in mind fig.5 and fig.8, it can be concluded that the solid chromium solution is significantly depleted leading to a major reduction of creep strength and brittle fracture.

The superheater is a vital part of the boiler and this paper proves that during overhaul, material control, chemical and metallographic, is vital in order to ensure uninterrupted operation of the power plant throughout the year.
