**METODOLOGIJA REPARATURNOG ZAVARIVANJA PRSLINA
NA LIVENOM DELU GLAVČINE ROTORA GENERATORA
AGREGATA A4 NA HIDROELEKTRANI ĐERDAP 1**

**METHODOLOGY OF REPAIR WELDING IN ZONES WHERE CRACKS
WERE DETECTED ON THE CASTED PART OF THE GENERATOR
ROTOR HUB OF THE HYDROELECTRIC GENERATING
SET A4 AT HYDRO POWER PLANT DJERDAP 1**

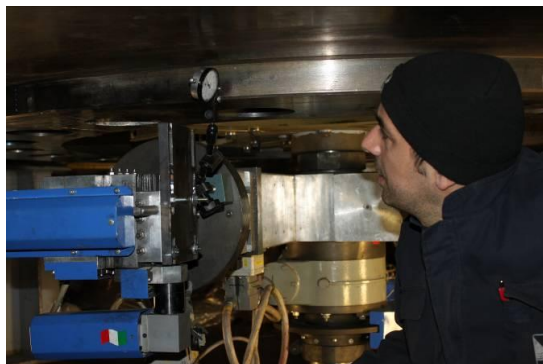
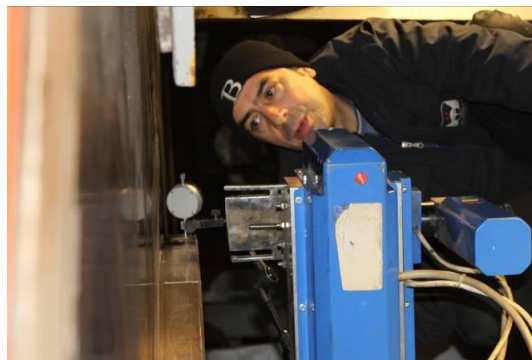
Figure 9. Planeness test for flange surface carried out by measure controller

Inspection of surface condition regarding the deformations of the generator rotor hub (planeness test) was carried out before, during and after welding / surface welding, by positioning 2 m long ruler tangentially with respect to the internal edge of the hub flange at many locations and in areas where grinding occurred (positions I – I and II – II), which is presented in figure 8, while planeness test carried out by the measure controller is shown in figure 9. At measurement locations a, b, c and d for position I – I, as well as e, f, g and h for position II – II, the clearance was determined by measure controllers. Results of clearance measurement are presented in table 8 [5].

Ruler position	Measurement location	Date of measurement				Allowable deviation*) [mm]
		First measurement	Second measurement	Third measurement	Fourth measurement	
I – I	a					0
	b					0,03
	c					0,03
	d					0
II – II	e					0
	f					0,03
	g					0,03
	h					0
(III – III)**	i					0
	j					0,03
	k					0
(IV – IV)**	l					0
	m					0,03
	n					0
*)	For the turbine shaft flange, which is being connected with the rotor hub flange, allowable value of planeness deviance is 0,03 mm.					
**))	Ruler positions are not shown in fig. 8
