## ANALYSIS OF CURRENT STATE AND INTEGRITY EVALUATION OF THE PIPELINE AT HYDRO POWER PLANT 'PIROT'

*Key words: hydroelectric generating set, crack, repair technology, pipeline integrity*

This paper contains the analysis of current state and integrity evaluation of the pipeline as a whole on the basis of results of non - destructive tests performed on the vital butt - welded joint in the curvature area at chainage 1+263 m (visual testing, magnetic particle testing, penetrant testing, ultrasonic testing, radiographic testing, metallographic replication testing).

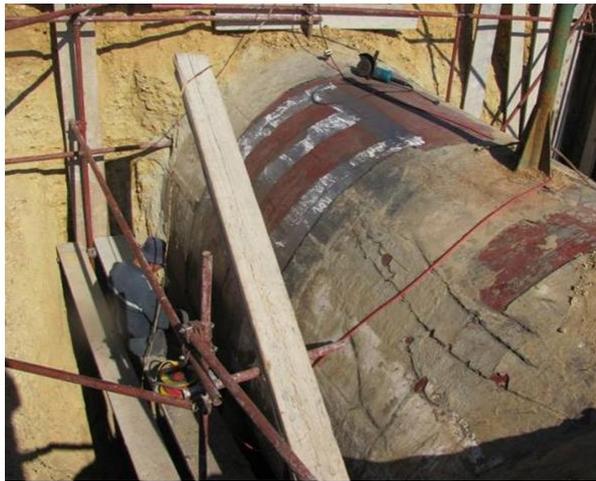
a) Preparation of the external pipeline surface

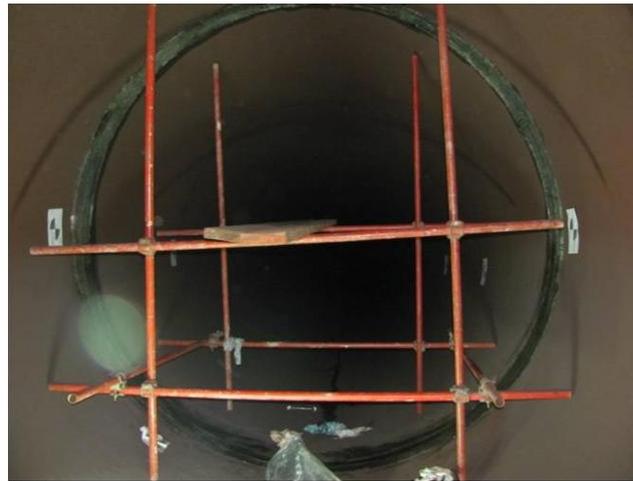
b) Preparation of the internal pipeline surface

*Figure 3. Appearance of preparation of the vital welded joint by grinding in order to perform NDT*

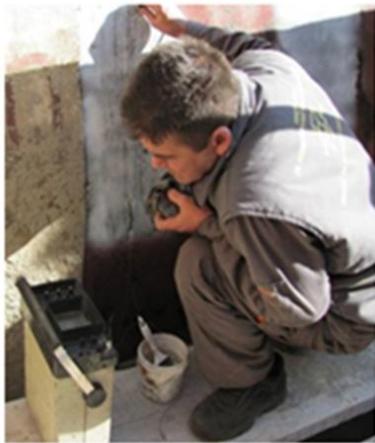
Ultrasonic testing was performed on parent material and weld metal [6] in order to determine depths of surface cracks. It was determined that cracks in parent material are 1,5-2,5 mm deep, while cracks in weld metal are 3,5 - 10,0 mm deep. Process of ultrasonic testing of the butt - welded joint, as well as location of the 10 mm deep surface crack are presented in figure 7.

a) Process of ultrasonic testing

**Figure 7.** Determination of depths of surface cracks in the area of the butt - welded joint
